SONOMA COUNTY FIRE DISTRICT MASTER PLAN

FINAL REPORT | DEC 23, 2024

PREPARED BY KITCHELL AND SHAH KAWASAKI ARCHITECTS

Sonoma County Fire District
Facility Condition Assessment
MAY 31, 2024

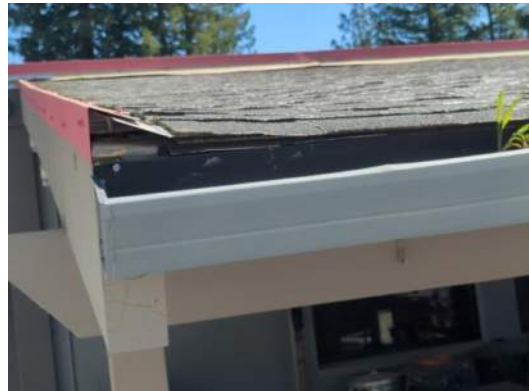
Item No.: B3010.90.001
Floor/Room: Roof / Rear Porch
Priority: **Crucial (1-2 Years)**
Quantity/Unit of Measure: 30/LF
Total Deficiency Cost: \$5,090
Deficiency Description: *Roof flashing is missing.*

Description of Work: *Replace missing flashing.*

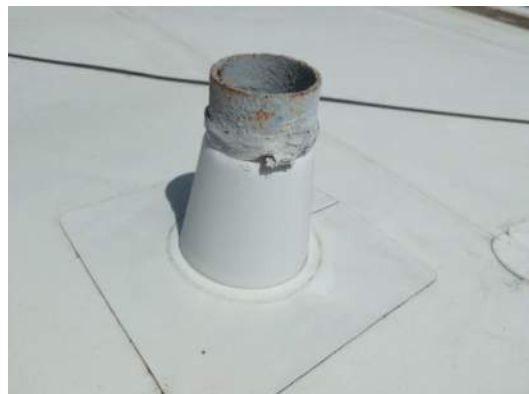
Item No.: B2010.50.004
Floor/Room: Roof / -
Priority: **Necessary - Long Term (3-4 Years)**
Quantity/Unit of Measure: 5/LF
Total Deficiency Cost: \$30
Deficiency Description: *Elastomeric sealant at roof jack is deteriorating.*

Description of Work: *Remove old sealant, clean the associated joints and re-seal it with new sealant.*

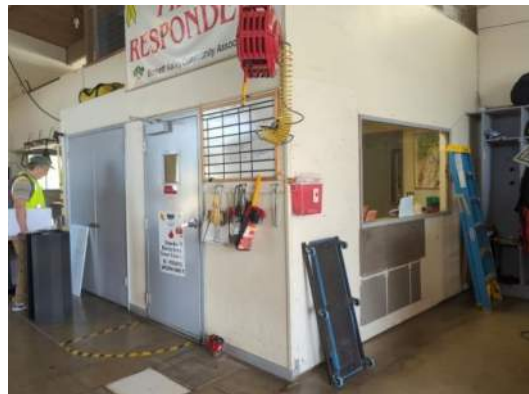
Item No.: C2010.70.001
Floor/Room: 1st Floor / Apparatus Bay
Priority: **Impending (2-3 Years)**
Quantity/Unit of Measure: 200/SF
Total Deficiency Cost: \$4,420
Deficiency Description: *Painted gypsum wallboard is showing signs of wear.*

Description of Work: *Patch and paint the gypsum wallboard.*

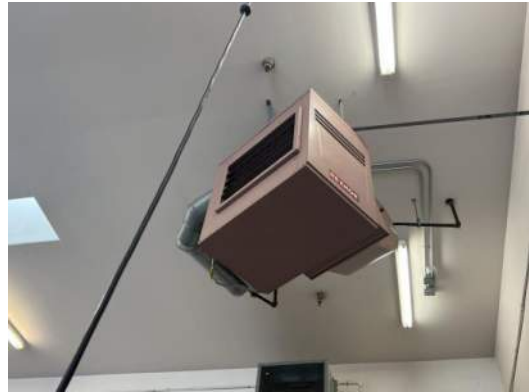
Item No.: D3020.70.003
Floor/Room: 1st Floor / Apparatus
Priority: **Planned - Long Term (6-10 Years)**
Quantity/Unit of Measure: 1/EA
Total Deficiency Cost: \$14,800
Deficiency Description: *Gas fired unit heater is approaching the end of its expected useful life.*

Description of Work: *Provide equipment replacement and installation.*
