SONOMA COUNTY FIRE DISTRICT MASTER PLAN

FINAL REPORT | DEC 23, 2024

PREPARED BY KITCHELL AND SHAH KAWASAKI ARCHITECTS

Sonoma County Fire District
Facility Condition Assessment
MAY 31, 2024

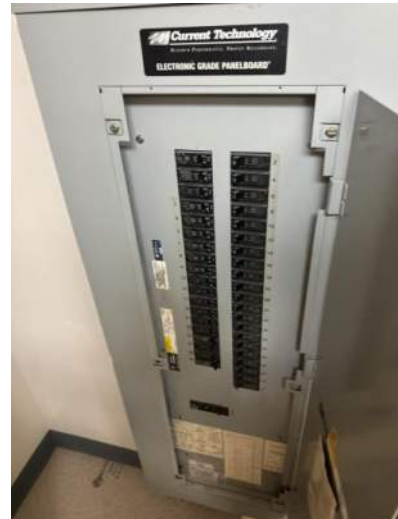
Record ID: 776
System: D5020 - ELECTRICAL SERVICE AND DISTRIBUTION
Item No.: D5020.30.1008
Floor/Room: 2nd Floor / Closet
Priority: Necessary - Long Term (3-4 Years)
Quantity/Unit of Measure: 1/EA
Total Deficiency Cost: \$21,330
Deficiency Description: The 225A (42 ckts, 120/208, 3P) panelboard is approaching the end of its expected useful life.

Description of Work: Replace the existing panelboard with a new panelboard.

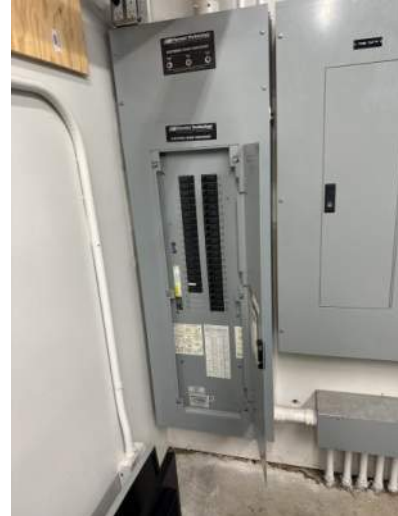
Record ID: 780
System: D5020 - ELECTRICAL SERVICE AND DISTRIBUTION
Item No.: D5020.30.1008
Floor/Room: 1st Floor / Electrical
Priority: Necessary - Long Term (3-4 Years)
Quantity/Unit of Measure: 1/EA
Total Deficiency Cost: \$21,330
Deficiency Description: *The 225A (42 ckts, 120/208, 3P) panelboard is approaching the end of its expected useful life.*

Description of Work: *Replace the existing panelboard with a new panelboard.*

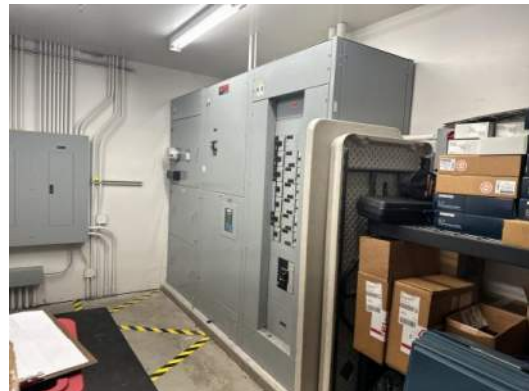
Record ID: 781
System: D5020 - ELECTRICAL SERVICE AND DISTRIBUTION
Item No.: D5020.30.0012
Floor/Room: 1st Floor / Electrical
Priority: Necessary - Long Term (3-4 Years)
Quantity/Unit of Measure: 3/EA
Total Deficiency Cost: \$146,360
Deficiency Description: *The 1000A 3-section main switchboard is approaching the end of its expected useful life.*

Description of Work: *Replace the existing switchboard with a new switchboard.*

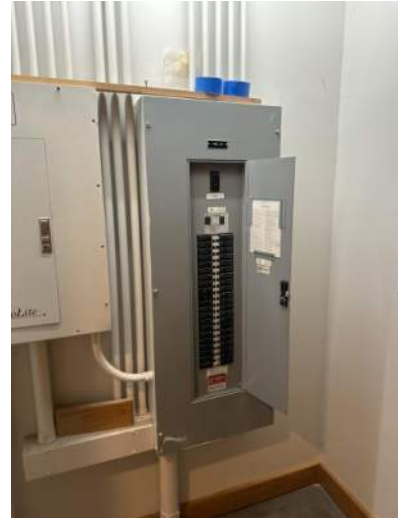
Record ID: 783
System: D5020 - ELECTRICAL SERVICE AND DISTRIBUTION

Item No.: D5020.30.1008
Floor/Room: 1st Floor / Closet
Priority: Necessary - Long Term (3-4 Years)
Quantity/Unit of Measure: 1/EA
Total Deficiency Cost: \$21,330
Deficiency Description: *The 225A (42 ckts, 120/208, 3P) panelboard is approaching the end of its expected useful life.*

Description of Work: *Replace the existing panelboard with a new panelboard.*

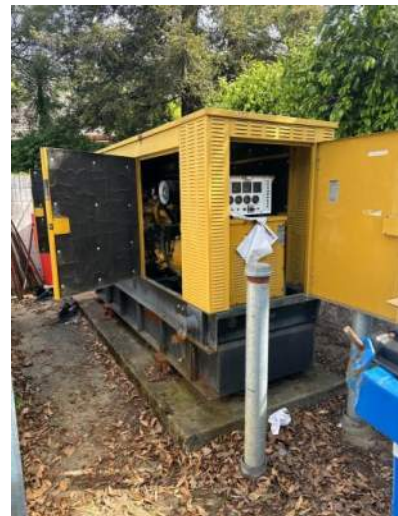
Record ID: 784
System: D5010 - FACILITY POWER GENERATION

Item No.: D5010.10.003
Floor/Room: Site / -
Priority: Immediate (0-1 Years)
Quantity/Unit of Measure: 1/EA
Total Deficiency Cost: \$143,780
Deficiency Description: *The 100kW Diesel engine (including battery, charger, muffler, day tank) is at or is approaching end of its expected useful life.*

Description of Work: *Replace the existing generator with an appropriately sized new generator.*

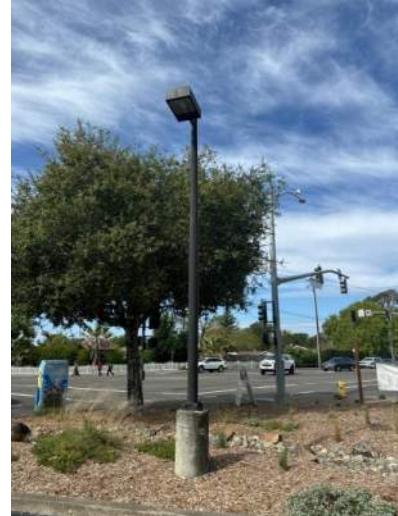
Record ID: 786
System: G2020 - PARKING LOTS
Item No.: G2020.70.014
Floor/Room: Site / -
Priority: Immediate (0-1 Years)
Quantity/Unit of Measure: 5/EA
Total Deficiency Cost: \$4,670
Deficiency Description: Existing lighting pole shows wear and should be retrofitted to be an LED fixture.

Description of Work: Retrofit the lighting pole with an LED fixture, clean and repaint pole.

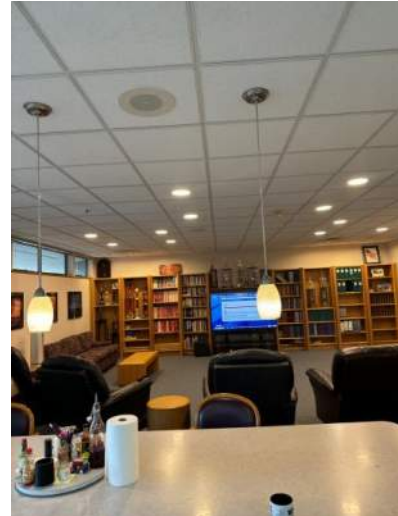
Record ID: 787
System: D5040 - LIGHTING
Item No.: D5040.50.009
Floor/Room: All / Various
Priority: Potential - Long Term (4-5 Years)
Quantity/Unit of Measure: 17,800/SF
Total Deficiency Cost: \$1,178,650
Deficiency Description: Interior lighting systems are at or are approaching the end of their expected useful lives.

Comments: Lighting past its expected life but in but in good condition.

Description of Work: Replace the existing interior lighting systems and associated wiring devices, switches and controls.

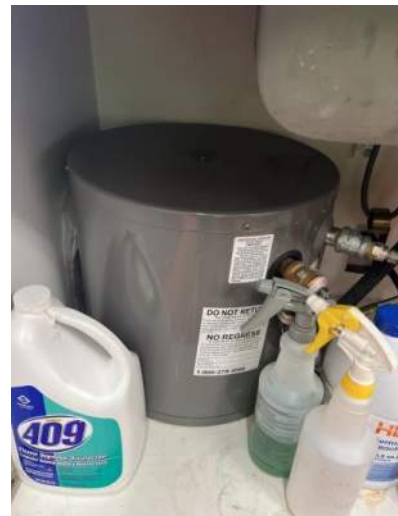
Record ID: 792
System: D2010 - DOMESTIC WATER DISTRIBUTION
Item No.: D2010.20.020
Floor/Room: 1st Floor / Apparatus
Priority: Planned - Long Term (6-10 Years)
Quantity/Unit of Measure: 1/EA
Total Deficiency Cost: \$4,110
Deficiency Description: Electric water heater is approaching the end of its expected useful life.

Description of Work: Provide equipment replacement and installation.

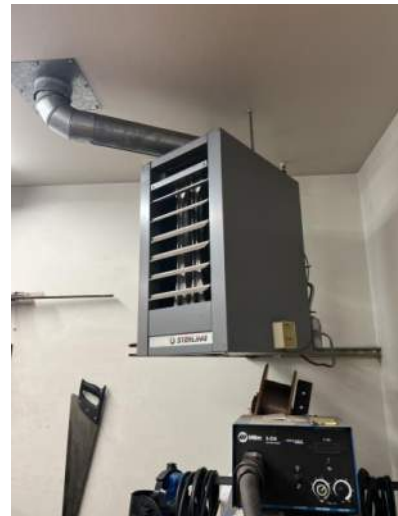
Record ID: 797
System: D3020 - HEATING SYSTEMS

Item No.: D3020.70.003
Floor/Room: 1st Floor / Tools
Priority: **Planned - Long Term (6-10 Years)**
Quantity/Unit of Measure: 1/EA
Total Deficiency Cost: \$14,800
Deficiency Description: *Gas fired unit heater is approaching the end of its expected useful life.*

Description of Work: *Provide equipment replacement and installation.*

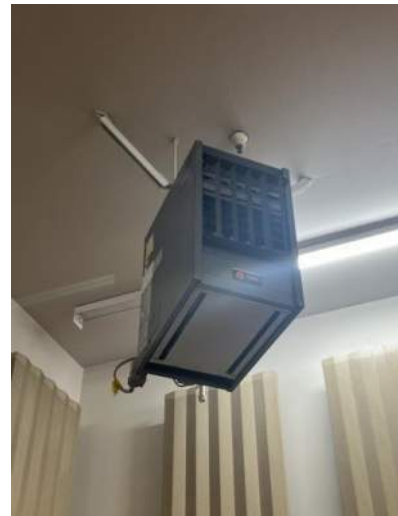
Record ID: 802
System: D3020 - HEATING SYSTEMS

Item No.: D3020.70.003
Floor/Room: 1st Floor / Apparatus
Priority: **Planned - Long Term (6-10 Years)**
Quantity/Unit of Measure: 1/EA
Total Deficiency Cost: \$14,800
Deficiency Description: *Gas fired unit heater is approaching the end of its expected useful life.*

Description of Work: *Provide equipment replacement and installation.*

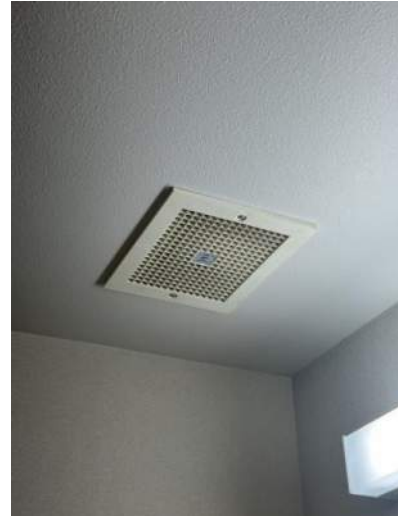
Record ID: 820
System: D3060 - VENTILATION

Item No.: D3060.30.002
Floor/Room: 2nd Floor / Bath 1
Priority: **Impending (2-3 Years)**
Quantity/Unit of Measure: 1/EA
Total Deficiency Cost: \$2,470
Deficiency Description: *Ceiling exhaust fan is approaching the end of its expected useful life.*

Description of Work: *Provide equipment replacement and installation.*

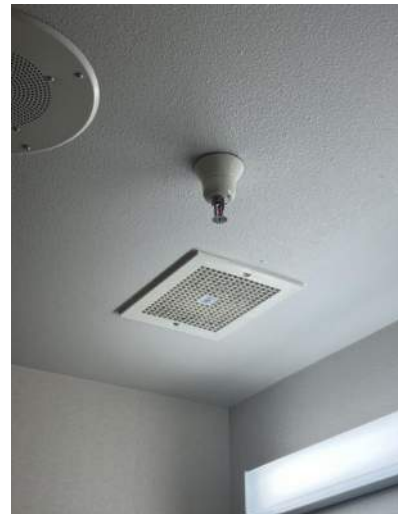
Record ID: 821
System: D3060 - VENTILATION

Item No.: D3060.30.002
Floor/Room: 2nd Floor / Bath 2
Priority: **Impending (2-3 Years)**
Quantity/Unit of Measure: 1/EA
Total Deficiency Cost: \$2,470
Deficiency Description: *Ceiling exhaust fan is approaching the end of its expected useful life.*

Description of Work: *Provide equipment replacement and installation.*

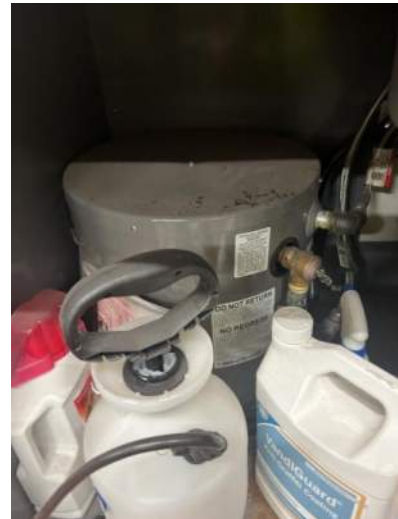
Record ID: 823
System: D2010 - DOMESTIC WATER DISTRIBUTION

Item No.: D2010.20.020
Floor/Room: 1st Floor / Tools
Priority: **Planned - Long Term (6-10 Years)**
Quantity/Unit of Measure: 1/EA
Total Deficiency Cost: \$4,110
Deficiency Description: *Electric water heater is approaching the end of its expected useful life.*

Description of Work: *Provide equipment replacement and installation.*

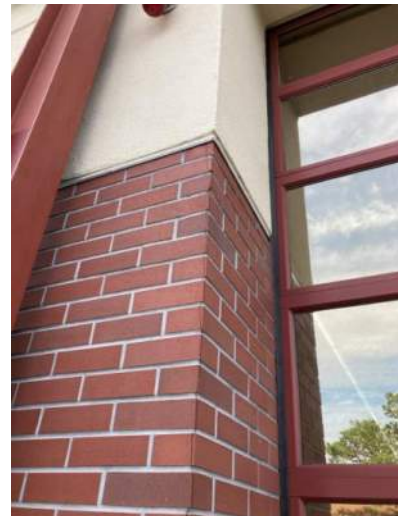
Record ID: 898
System: B2010 - EXTERIOR WALLS

Item No.: B2010.10.004
Floor/Room: Site / -
Priority: **Potential - Long Term (4-5 Years)**
Quantity/Unit of Measure: 50/LF
Total Deficiency Cost: \$2,880
Deficiency Description: *Brick veneer damaged; crack runs from top to bottom of building corner.*

Description of Work: *Repair brick masonry.*

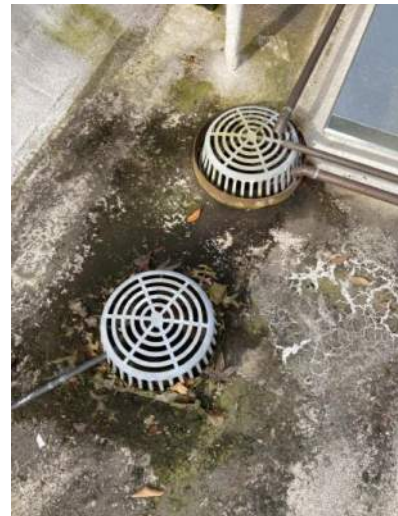
Record ID: 901
System: D2030 - BUILDING SUPPORT PLUMBING SYSTEMS

Item No.: D2030.30.001
Floor/Room: Roof / -
Priority: Crucial (1-2 Years)
Quantity/Unit of Measure: 2/EA
Total Deficiency Cost: \$6,780
Deficiency Description: *Roof drains are damaged and clogged.*

Description of Work: *Repair or replace roof drains.*

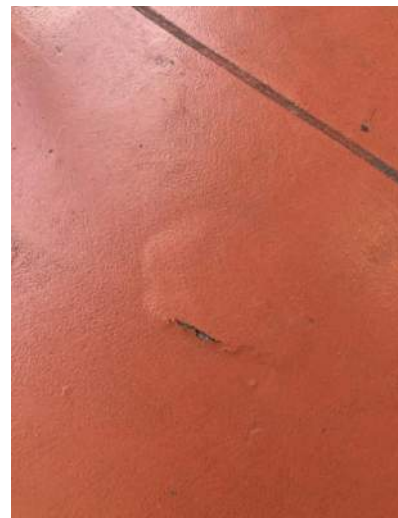
Record ID: 904
System: C2030 - FLOORING

Item No.: C2030.10.002
Floor/Room: 1st Floor / App bay
Priority: **Potential - Long Term (4-5 Years)**
Quantity/Unit of Measure: 5,600/SF
Total Deficiency Cost: \$322,450
Deficiency Description: *Epoxy flooring is approaching the end of its useful life.*

Description of Work: *Remove the existing epoxy and replace.*

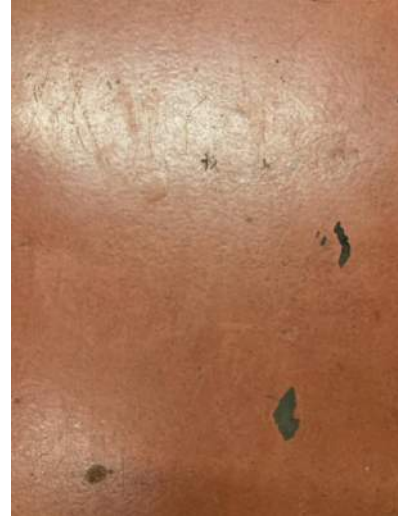
Item No.: C2030.10.002
Floor/Room: 1st Floor / Shop
Priority: Potential - Long Term (4-5 Years)
Quantity/Unit of Measure: 200/SF
Total Deficiency Cost: \$11,530
Deficiency Description: *Epoxy is approaching the end of its useful life.*

Description of Work: *Remove the existing epoxy and replace.*

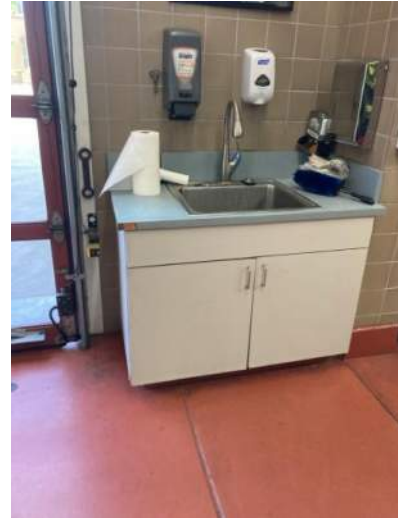
Record ID: 906
System: E2010 - FIXED FURNISHINGS

Item No.: E2010.30.008
Floor/Room: 1st Floor / App bay
Priority: Potential - Long Term (4-5 Years)
Quantity/Unit of Measure: 10/LF
Total Deficiency Cost: \$19,580
Deficiency Description: *Plastic laminate base cabinet and countertop are in poor condition.*

Description of Work: *Remove and replace with new plastic laminate base cabinet and countertop.*

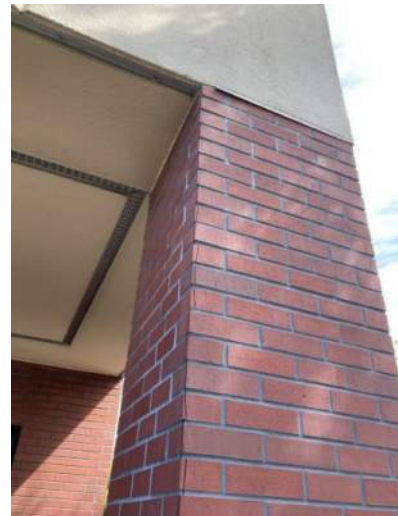
Record ID: 907
System: B2010 - EXTERIOR WALLS

Item No.: B2010.10.004
Floor/Room: Site / -
Priority: Potential - Long Term (4-5 Years)
Quantity/Unit of Measure: 50/LF
Total Deficiency Cost: \$2,880
Deficiency Description: *Brick veneer damaged; crack runs from top to bottom of column corner*

Description of Work: *Repair brick masonry.*

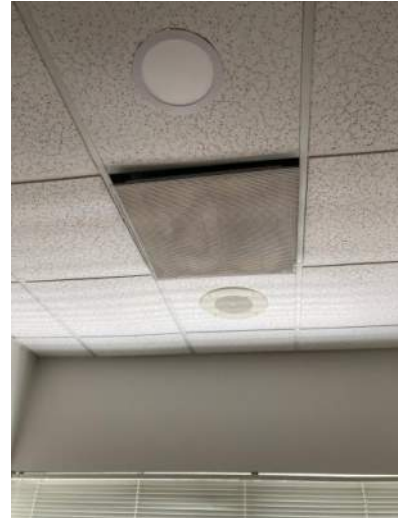
Record ID: 909
System: D3060 - VENTILATION

Item No.: D3060.70.001
Floor/Room: 1st Floor / Dorm 7
Priority: Potential - Long Term (4-5 Years)
Quantity/Unit of Measure: 4/SF
Total Deficiency Cost: \$30
Deficiency Description: *Loose air register.*

Description of Work: *Provide equipment maintenance.*

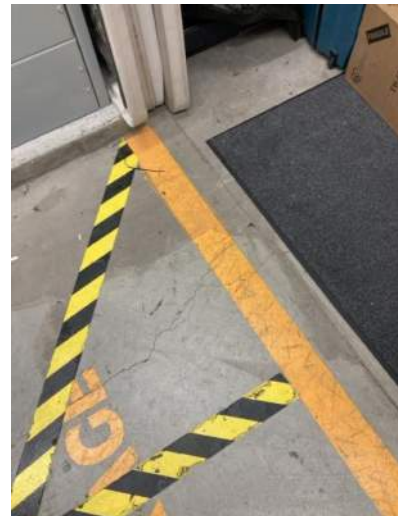
Record ID: 910
System: A4010 - STANDARD SLABS-ON-GRADE

Item No.: A4010.10.001
Floor/Room: 1st Floor / Electrical room
Priority: Potential - Long Term (4-5 Years)
Quantity/Unit of Measure: 15/LF
Total Deficiency Cost: \$400
Deficiency Description: *Moderate cracking in concrete slab in electrical room.*

Description of Work: *Fill the slab-on-grade cracks with caulking.*

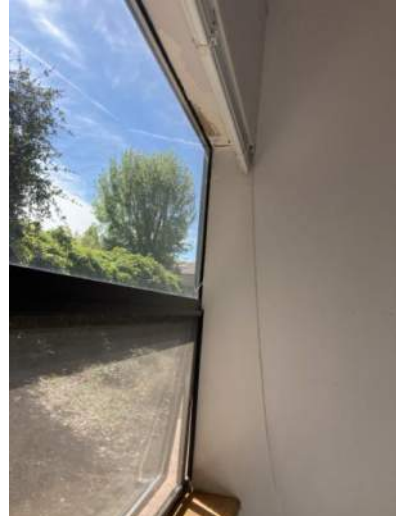
Item No.: C2010.70.001
Floor/Room: 1st Floor / Dorm 8
Priority: **Impending (2-3 Years)**
Quantity/Unit of Measure: 12/SF
Total Deficiency Cost: \$280
Deficiency Description: *Painted gypsum wallboard is showing signs of wear.*

Comments: *Water damage observed above windows in Dorm Rooms 7 & 8.*

Description of Work: *Patch and paint the gypsum wallboard.*

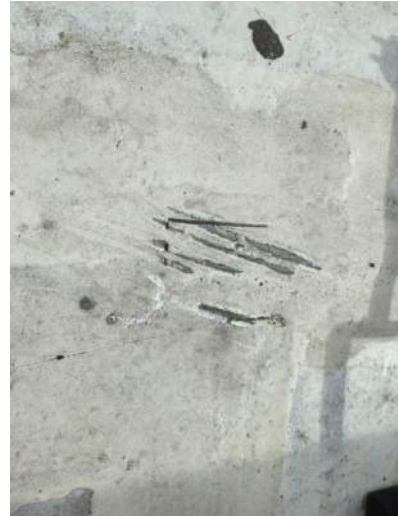
Record ID: 946
System: B3010 - ROOFING

Item No.: B3010.50.004
Floor/Room: Roof / -
Priority: **Impending (2-3 Years)**
Quantity/Unit of Measure: 10/SF
Total Deficiency Cost: \$400
Deficiency Description: *Modified-bitumen roofing is showing signs of wear.*

Comments: *Located on the west end of the low slope roof.*

Description of Work: *Replace modified bitumen roofing.*

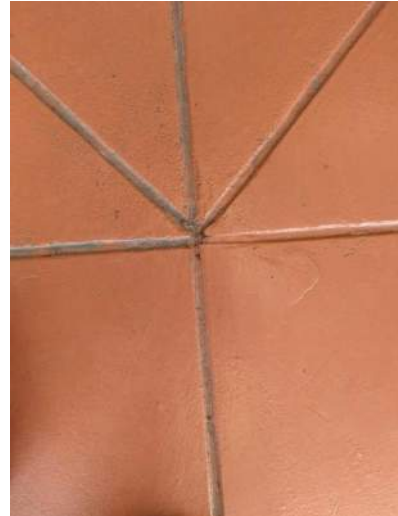
Record ID: 950
System: G2030 - PEDESTRIAN PLAZAS AND WALKWAYS

Item No.: G2030.20.002
Floor/Room: 1st Floor / Apparatus Bay
Priority: *Necessary - Long Term (3-4 Years)*
Quantity/Unit of Measure: 570/LF
Total Deficiency Cost: \$8,410
Deficiency Description: *The floor sealant on the slab control joints are failing.*

Description of Work: *Remove/replace pavement sealant at control joints.*

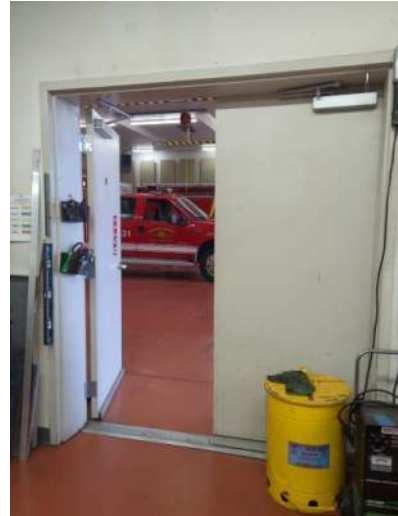
Record ID: 953
System: C1030 - INTERIOR DOORS

Item No.: C1030.90.003
Floor/Room: 1st Floor / Tools (Shop)
Priority: Necessary - Long Term (3-4 Years)
Quantity/Unit of Measure: 2/EA
Total Deficiency Cost: \$1,840
Deficiency Description: *Metal door and frames are in fair to poor condition.*

Description of Work: *Repair and refinish the metal door and frame.*

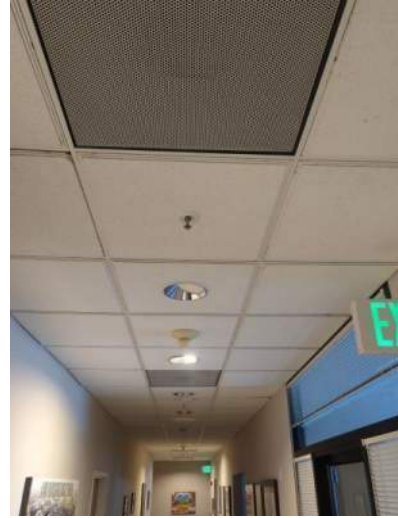
Item No.: C2050.80.001
Floor/Room: 1st Floor / South Corridor
Priority: Potential - Long Term (4-5 Years)
Quantity/Unit of Measure: 1,000/SF
Total Deficiency Cost: \$17,940
Deficiency Description: Lay-in acoustical ceiling tile is in poor condition.

Description of Work: Remove existing tiles and replace with new lay-in acoustical ceiling tiles.

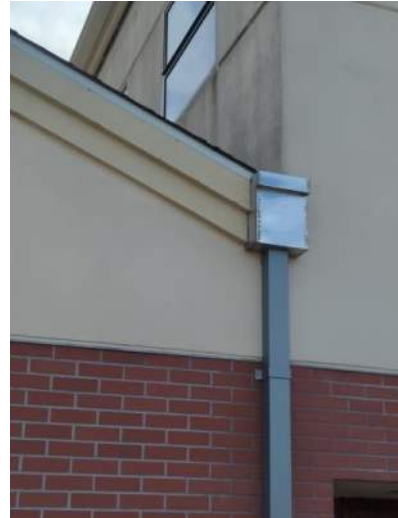
Record ID: 956
System: B3010 - ROOFING

Item No.: B3010.90.010
Floor/Room: Exterior / Exterior
Priority: Impending (2-3 Years)
Quantity/Unit of Measure: 12/LF
Total Deficiency Cost: \$430
Deficiency Description: The fascia is deteriorated and shows signs of wood rot.

Description of Work: Selectively remove deteriorated fascia and replace with new material to match.

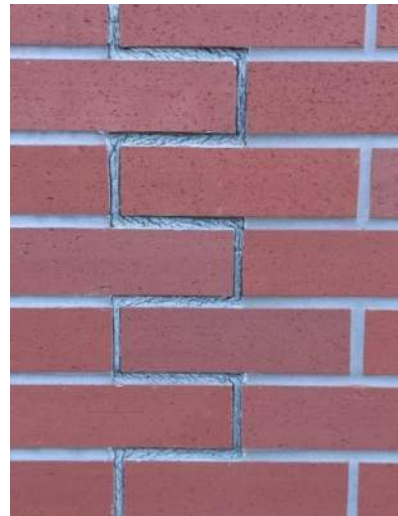
Record ID: 957
System: G2030 - PEDESTRIAN PLAZAS AND WALKWAYS

Item No.: G2030.20.002
Floor/Room: Exterior / Exterior
Priority: Impending (2-3 Years)
Quantity/Unit of Measure: 360/LF
Total Deficiency Cost: \$5,100
Deficiency Description: Brick control joint sealants are failing.

Comments: Full brick units are used at all control joints so joints are not vertical per typical practice.

Description of Work: Remove/replace pavement sealant at control joints.

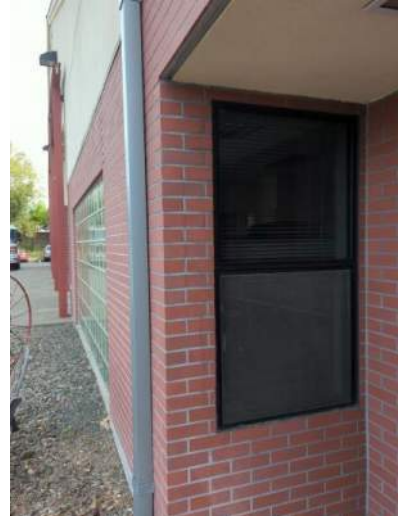
Record ID: 958
System: B2010 - EXTERIOR WALLS
Item No.: B2010.10.004
Floor/Room: 1st Floor / Exercise Room Exterior
Priority: **Impending (2-3 Years)**
Quantity/Unit of Measure: 5/LF
Total Deficiency Cost: \$280
Deficiency Description: *Brick masonry is showing signs of cracking.*

Description of Work: *Repair brick masonry.*

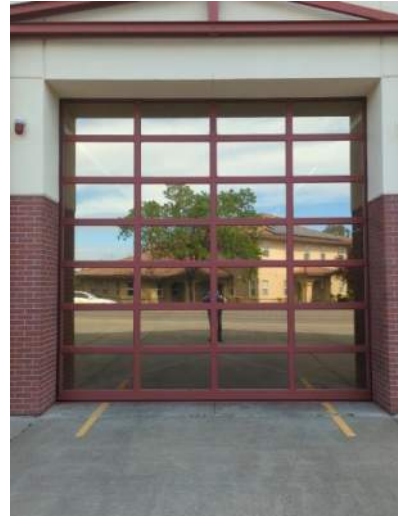
Record ID: 960
System: B2020 - EXTERIOR WINDOWS
Item No.: B2020.20.010
Floor/Room: 1st floor / Apparatus OH Doors
Priority: **Impending (2-3 Years)**
Quantity/Unit of Measure: 1,600/LF
Total Deficiency Cost: \$45,310
Deficiency Description: *Sealant for glazing panes are failing.*

Description of Work: *Replace window sealant.*

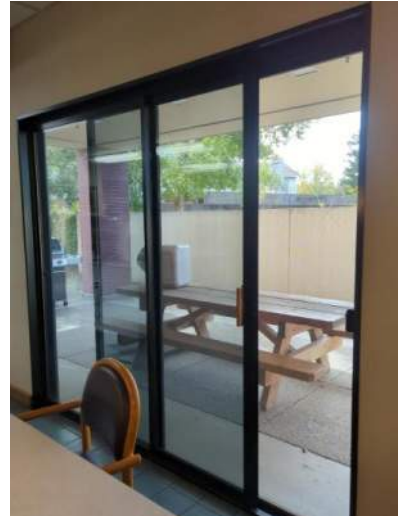
Record ID: 963
System: C1030 - INTERIOR DOORS

Item No.: C1030.25.002
Floor/Room: 1st Floor / Kitchen
Priority: Impending (2-3 Years)
Quantity/Unit of Measure: 2/EA
Total Deficiency Cost: \$2,130
Deficiency Description: *Interior door does not operate properly.*

Description of Work: *Repair interior aluminum sliding door.*

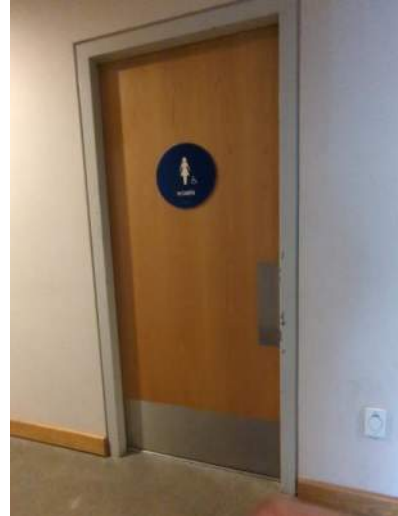
Item No.: C1030.90.003
Floor/Room: 1st Floor / -
Priority: Potential - Long Term (4-5 Years)
Quantity/Unit of Measure: 14/EA
Total Deficiency Cost: \$13,440
Deficiency Description: *Chipped paint on metal door frames.
Typical of all frames.*

Description of Work: *Repair and refinish the metal door frames.*

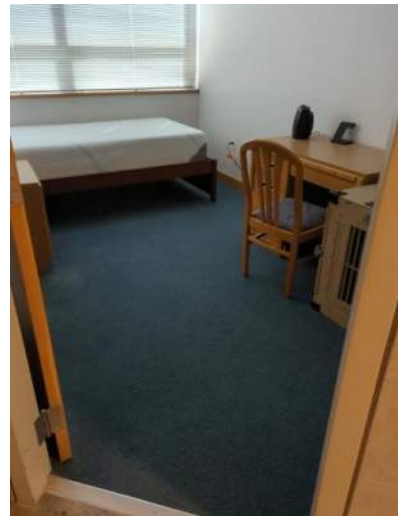
Record ID: 970
System: C2030 - FLOORING

Item No.: C2030.75.001
Floor/Room: 1st Floor / Dorms
Priority: Planned - Long Term (6-10 Years)
Quantity/Unit of Measure: 1,600/SF
Total Deficiency Cost: \$51,070
Deficiency Description: *Carpets are matted.*

Comments: *Typical to all dorms.*

Description of Work: *Replace carpet tile.*

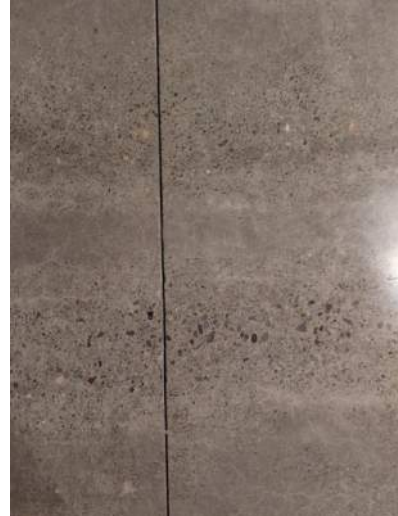
Record ID: 972
System: G2030 - PEDESTRIAN PLAZAS AND WALKWAYS
Item No.: G2030.20.002
Floor/Room: 1st Floor / East Corridor
Priority: Potential - Long Term (4-5 Years)
Quantity/Unit of Measure: 1,000/LF
Total Deficiency Cost: \$15,350
Deficiency Description: No sealant in control joints.

Comments: Typical for all corridor joints.

Description of Work: Add sealant at control joints.

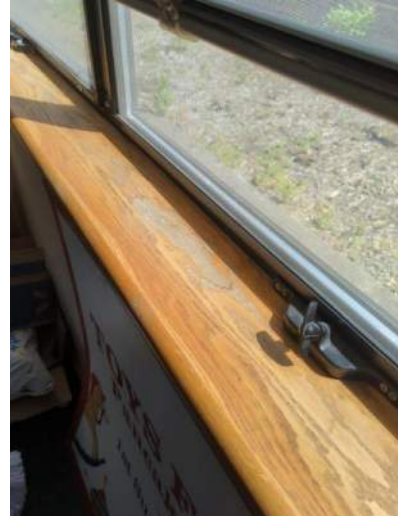
Record ID: 973
System: C1020 - INTERIOR WINDOWS
Item No.: C1020.90.001
Floor/Room: 1st Floor / Chief Dorm
Priority: Impending (2-3 Years)
Quantity/Unit of Measure: 1/EA
Total Deficiency Cost: \$710
Deficiency Description: Warped/damaged window sill.

Description of Work: Remove and replace the existing wood sill with new wood sill.

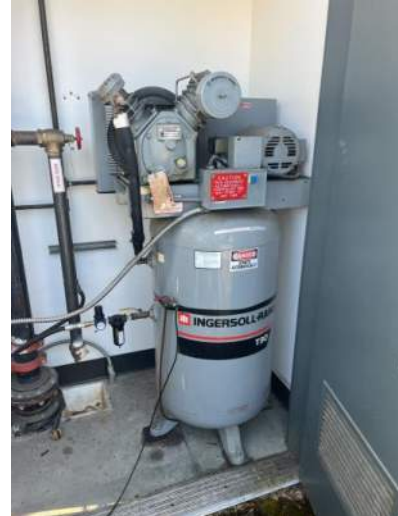
Record ID: 648
System: D2060 - PROCESS SUPPORT PLUMBING SYSTEMS
Item No.: D2060.10.001
Floor/Room: 1st Floor / Fire Riser
Priority: **Planned - Long Term (6-10 Years)**
Quantity/Unit of Measure: 1/EA
Total Deficiency Cost: \$19,930
Deficiency Description: *Air compressor is approaching the end of its expected useful life.*

Description of Work: *Provide equipment replacement and installation.*

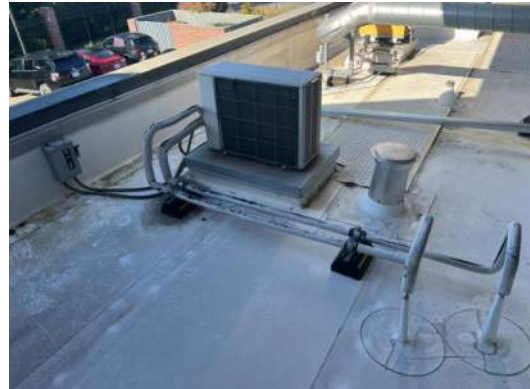
Record ID: 650
System: D3030 - COOLING SYSTEMS
Item No.: D3030.70.014
Floor/Room: Roof / -
Priority: **Crucial (1-2 Years)**
Quantity/Unit of Measure: 1/EA
Total Deficiency Cost: \$25,420
Deficiency Description: *Split ductless AC unit is approaching the end of its expected useful life.*

Comments: *Serves Fitness Room.*

Description of Work: *Provide equipment replacement and installation.*

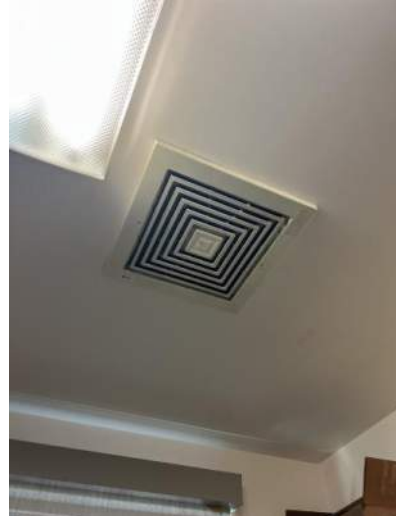
Item No.: D3060.30.002
Floor/Room: 1st Floor / Clean Shop
Priority: Potential - Long Term (4-5 Years)
Quantity/Unit of Measure: 1/EA
Total Deficiency Cost: \$2,680
Deficiency Description: *Ceiling exhaust fan is approaching the end of its expected useful life.*

Description of Work: *Provide equipment replacement and installation.*

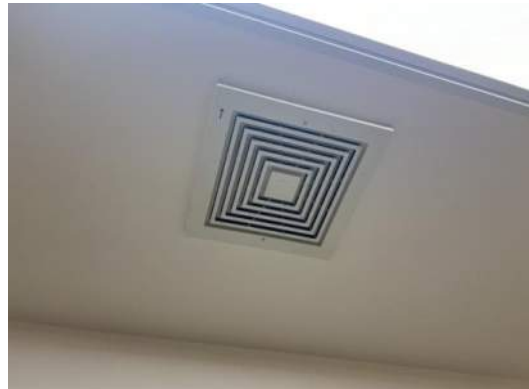
Record ID: 654
System: D3060 - VENTILATION

Item No.: D3060.30.002
Floor/Room: 1st Floor / App Bay Restroom
Priority: Potential - Long Term (4-5 Years)
Quantity/Unit of Measure: 1/EA
Total Deficiency Cost: \$2,680
Deficiency Description: *Ceiling exhaust fan is approaching the end of its expected useful life.*

Description of Work: *Provide equipment replacement and installation.*

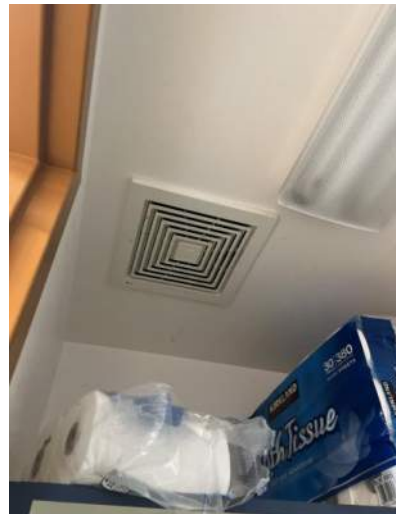
Record ID: 659
System: D3060 - VENTILATION

Item No.: D3060.30.002
Floor/Room: 1st Floor / Janitor
Priority: Potential - Long Term (4-5 Years)
Quantity/Unit of Measure: 1/EA
Total Deficiency Cost: \$2,680
Deficiency Description: *Ceiling exhaust fan is approaching the end of its expected useful life.*

Description of Work: *Provide equipment replacement and installation.*

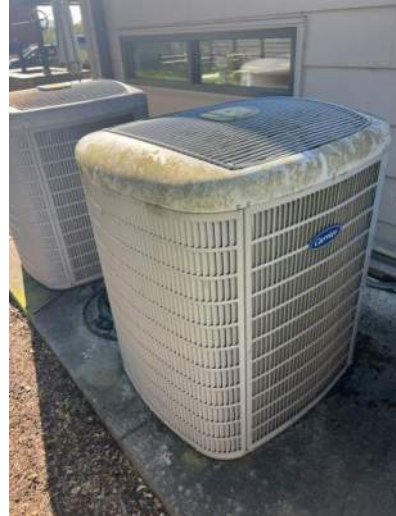
Item No.: D3030.70.007
Floor/Room: Site / Site
Priority: **Crucial (1-2 Years)**
Quantity/Unit of Measure: 1/EA
Total Deficiency Cost: \$14,240
Deficiency Description: *Split system with furnace heating and (3-ton) outdoor condensing unit is approaching the end of its expected useful life.*

Description of Work: *Provide equipment replacement and installation.*

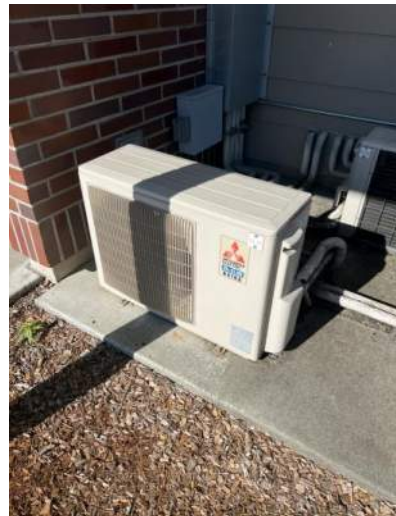
Record ID: 662
System: D3030 - COOLING SYSTEMS

Item No.: D3030.70.014
Floor/Room: Site / Site
Priority: **Crucial (1-2 Years)**
Quantity/Unit of Measure: 1/EA
Total Deficiency Cost: \$25,420
Deficiency Description: *Split ductless AC unit is approaching the end of its expected useful life.*

Description of Work: *Provide equipment replacement and installation.*

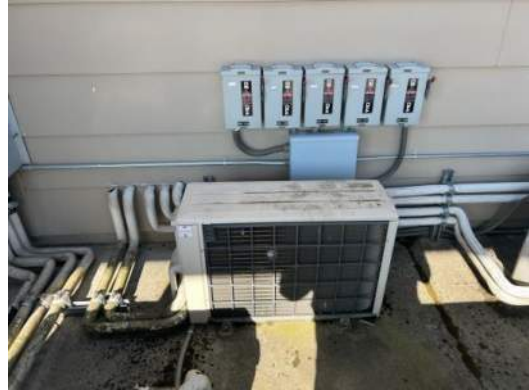
Item No.: D3030.70.014
Floor/Room: Site / Site
Priority: **Crucial (1-2 Years)**
Quantity/Unit of Measure: 1/EA
Total Deficiency Cost: \$25,420
Deficiency Description: *Split ductless AC unit is approaching the end of its expected useful life.*

Description of Work: *Provide equipment replacement and installation.*

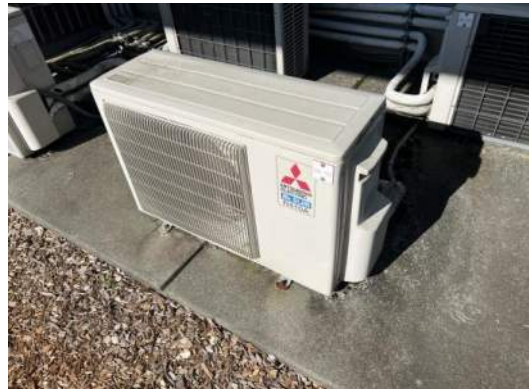
Record ID: 664
System: D3030 - COOLING SYSTEMS

Item No.: D3030.70.014
Floor/Room: Site / -
Priority: **Crucial (1-2 Years)**
Quantity/Unit of Measure: 1/EA
Total Deficiency Cost: \$25,420
Deficiency Description: *Split ductless AC unit is approaching the end of its expected useful life.*

Description of Work: *Provide equipment replacement and installation.*

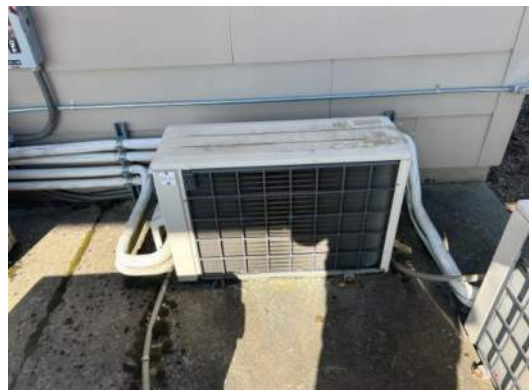
Record ID: 665
System: D3030 - COOLING SYSTEMS

Item No.: D3030.70.014
Floor/Room: Site / Site
Priority: **Crucial (1-2 Years)**
Quantity/Unit of Measure: 1/EA
Total Deficiency Cost: \$25,420
Deficiency Description: *Split ductless AC unit is approaching the end of its expected useful life.*

Description of Work: *Provide equipment replacement and installation.*

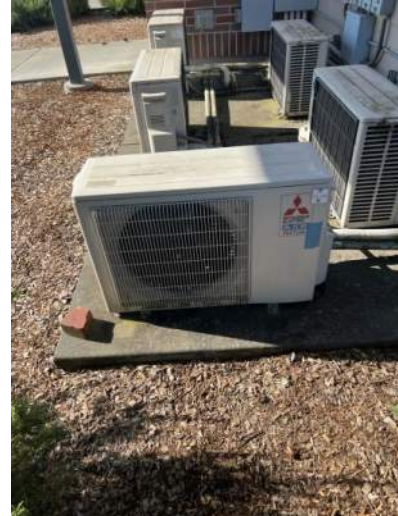
Record ID: 666
System: D3030 - COOLING SYSTEMS

Item No.: D3030.70.014
Floor/Room: Site / Site
Priority: **Crucial (1-2 Years)**
Quantity/Unit of Measure: 1/EA
Total Deficiency Cost: \$25,420
Deficiency Description: *Split ductless AC unit is approaching the end of its expected useful life.*

Description of Work: *Provide equipment replacement and installation.*

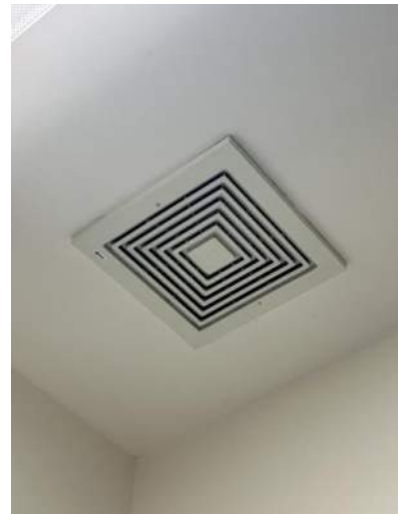
Record ID: 676
System: D3060 - VENTILATION

Item No.: D3060.30.002
Floor/Room: 1st Floor / Laundry
Priority: **Potential - Long Term (4-5 Years)**
Quantity/Unit of Measure: 1/EA
Total Deficiency Cost: \$2,680
Deficiency Description: *Ceiling exhaust fan is approaching the end of its expected useful life.*

Description of Work: *Provide equipment replacement and installation.*

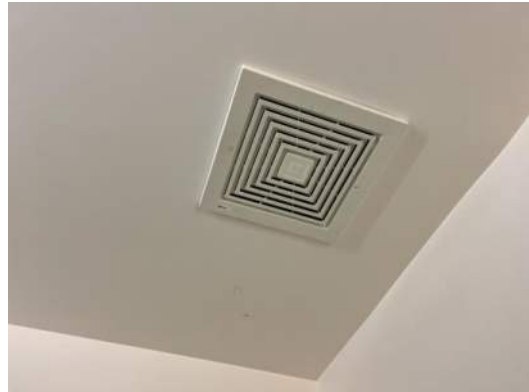
Item No.: D3060.30.002
Floor/Room: 1st Floor / Public Restroom
Priority: Potential - Long Term (4-5 Years)
Quantity/Unit of Measure: 1/EA
Total Deficiency Cost: \$2,680
Deficiency Description: *Ceiling exhaust fan is approaching the end of its expected useful life.*

Description of Work: *Provide equipment replacement and installation.*

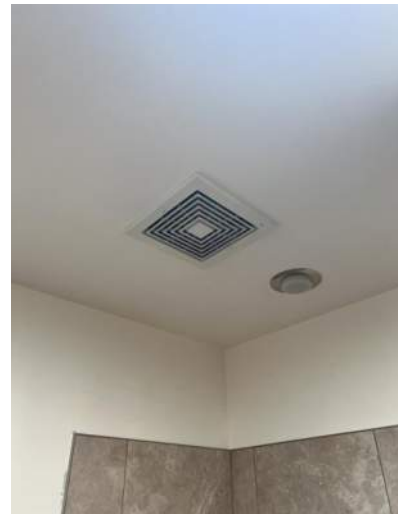
Record ID: 680
System: D3060 - VENTILATION

Item No.: D3060.30.002
Floor/Room: 1st Floor / Restroom 2
Priority: Potential - Long Term (4-5 Years)
Quantity/Unit of Measure: 1/EA
Total Deficiency Cost: \$2,680
Deficiency Description: *Ceiling exhaust fan is approaching the end of its expected useful life.*

Description of Work: *Provide equipment replacement and installation.*

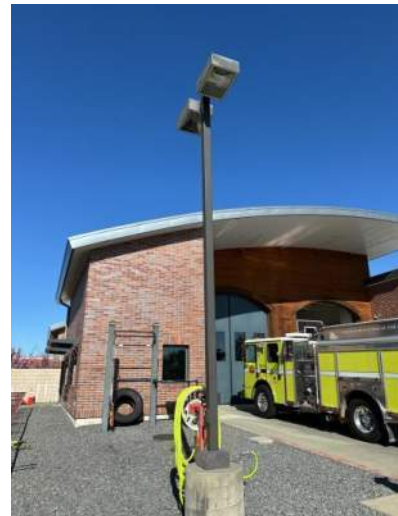
Record ID: 740
System: G2020 - PARKING LOTS

Item No.: G2020.70.014
Floor/Room: Site / -
Priority: Potential - Long Term (4-5 Years)
Quantity/Unit of Measure: 1/EA
Total Deficiency Cost: \$1,110
Deficiency Description: *Existing lighting pole shows wear and should be retrofitted to be an LED fixture.*

Description of Work: *Retrofit the lighting pole with an LED fixture, clean and repaint pole.*

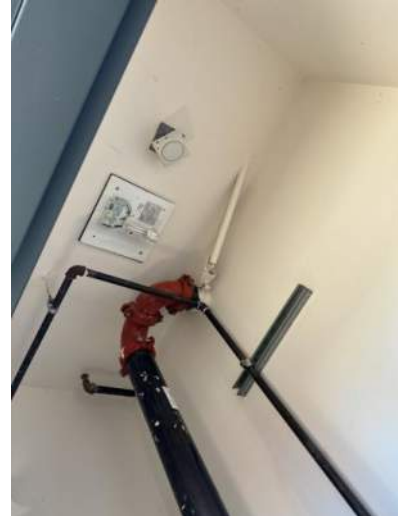
Item No.: D5040.50.003
Floor/Room: 1st / Fire sprinkler Room
Priority: Immediate (0-1 Years)
Quantity/Unit of Measure: 2/EA
Total Deficiency Cost: \$1,220
Deficiency Description: *Light fixture and motion sensor are damaged.*

Description of Work: *Replace the existing interior light fixture and sensore with new.*

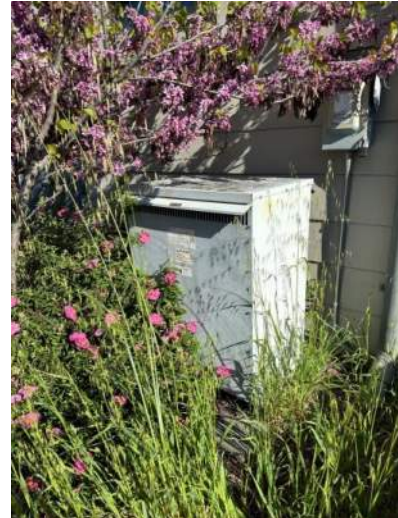
Record ID: 743
System: G2080 - LANDSCAPING

Item No.: G2080.30.007
Floor/Room: Site / -
Priority: Immediate (0-1 Years)
Quantity/Unit of Measure: 75/SF
Total Deficiency Cost: \$880
Deficiency Description: *Exterior dry-type transformer is in contact with landscaping.*

Description of Work: *Create a clear space around equipment.*

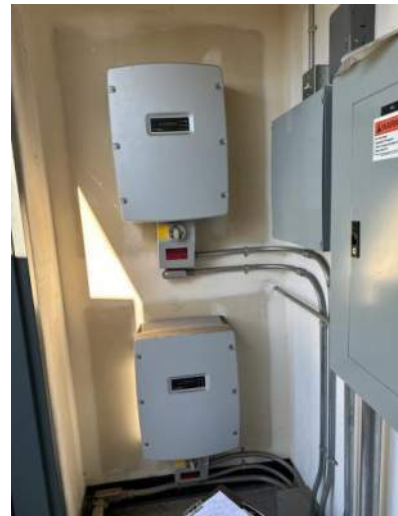
Record ID: 744
System: D5010 - FACILITY POWER GENERATION

Item No.: D5010.30.003
Floor/Room: 1st / Electrical
Priority: Potential - Long Term (4-5 Years)
Quantity/Unit of Measure: 10,000/W
Total Deficiency Cost: \$423,790
Deficiency Description: *The stand-alone photovoltaic power system is in need of being replaced.*

Description of Work: *Replace the existing stand-alone photovoltaic power system and replace it with a new one.*

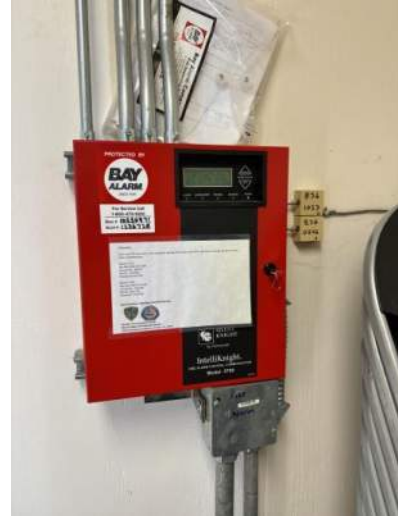
Item No.: D7050.10.022
Floor/Room: 1st / Various
Priority: Immediate (0-1 Years)
Quantity/Unit of Measure: 8,500/SF
Total Deficiency Cost: \$205,790
Deficiency Description: *The building existing fire alarm system is at the end of its industry rated useful life.*

Description of Work: *Provide a fully addressable fire alarm control panel with associated initiating and signaling devices.*

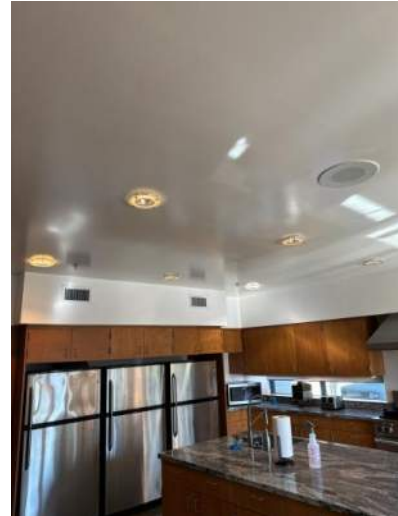
Record ID: 748
System: D5040 - LIGHTING

Item No.: D5040.50.009
Floor/Room: 1st Floor / Various
Priority: Potential - Long Term (4-5 Years)
Quantity/Unit of Measure: 8,500/SF
Total Deficiency Cost: \$562,860
Deficiency Description: *Interior lighting systems are at or are approaching the end of their expected useful lives.*

Description of Work: *Replace the existing interior lighting systems and associated wiring devices, switches and controls.*

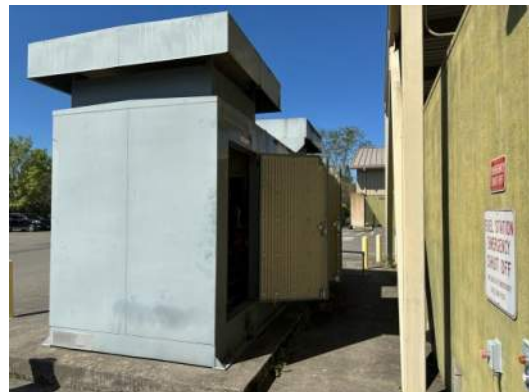
Record ID: 754
System: D5010 - FACILITY POWER GENERATION

Item No.: D5010.10.003
Floor/Room: Site / -
Priority: Immediate (0-1 Years)
Quantity/Unit of Measure: 1/EA
Total Deficiency Cost: \$143,780
Deficiency Description: *The fire station is served by a generator on the adjacent property that serves other buildings and is nearing the end its expected useful life.*

Description of Work: *Provide a new 100KW generator on the fire station dedicated to the facility.*

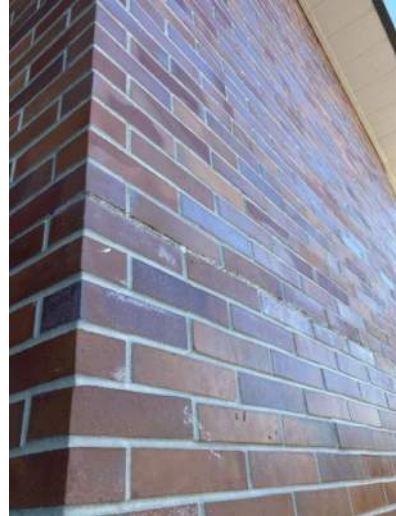
Item No.: B2010.10.004
Floor/Room: 1st Floor / Site
Priority: Potential - Long Term (4-5 Years)
Quantity/Unit of Measure: 400/LF
Total Deficiency Cost: \$23,030
Deficiency Description: *Cracking in sealant in horizontal brick joint was observed.*

Comments: *Failing sealant at brick at ledger angle.*

Description of Work: *Replace sealant in control joint.*

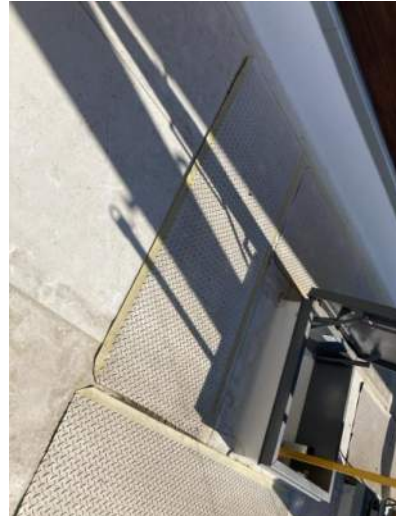
Record ID: 877
System: B3040 - TRAFFIC BEARING HORIZONTAL ENCLOSURES

Item No.: B3040.50.001
Floor/Room: Roof / -
Priority: Potential - Long Term (4-5 Years)
Quantity/Unit of Measure: 20/SF
Total Deficiency Cost: \$1,140
Deficiency Description: *Rooftop walk pads are loose.*

Description of Work: *Reattach walk pads on roofing membrane.*

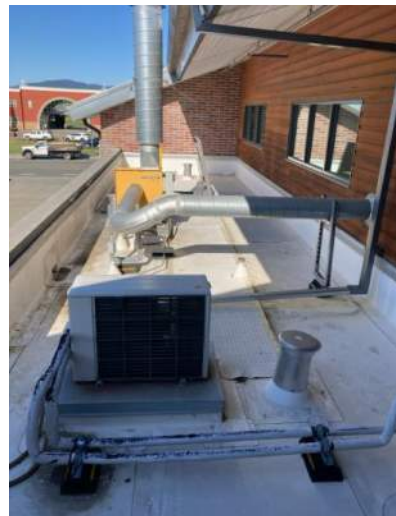
Record ID: 878
System: B3010 - ROOFING

Item No.: B3010.50.002
Floor/Room: Roof / -
Priority: Potential - Long Term (4-5 Years)
Quantity/Unit of Measure: 300/SF
Total Deficiency Cost: \$13,240
Deficiency Description: *Single-ply roofing is approaching the end of its useful life.*

Description of Work: *Remove and replace single-ply roofing.*

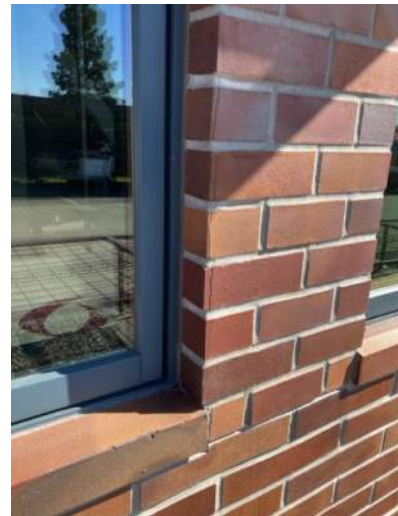
Record ID: 881
System: B2010 - EXTERIOR WALLS

Item No.: B2010.10.004
Floor/Room: Site / -
Priority: Potential - Long Term (4-5 Years)
Quantity/Unit of Measure: 50/LF
Total Deficiency Cost: \$2,880
Deficiency Description: Brick masonry is damaged.

Comments: Cracking brick masonry around windows on South façade.

Description of Work: Repair brick masonry.

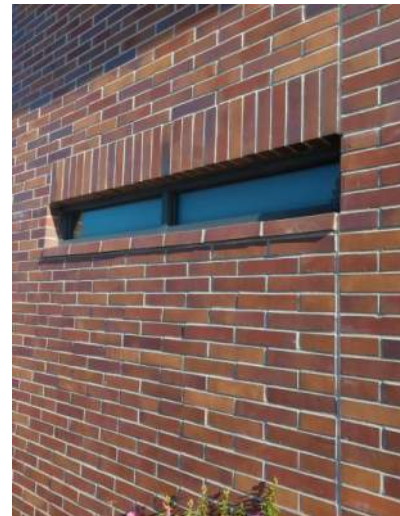
Record ID: 920
System: B2010 - EXTERIOR WALLS

Item No.: B2010.10.004
Floor/Room: Exterior / Exterior
Priority: Impending (2-3 Years)
Quantity/Unit of Measure: 10/LF
Total Deficiency Cost: \$530
Deficiency Description: Hairline fractures on brick were observed.

Comments: Located on the SW corner.

Description of Work: Repair brick masonry.

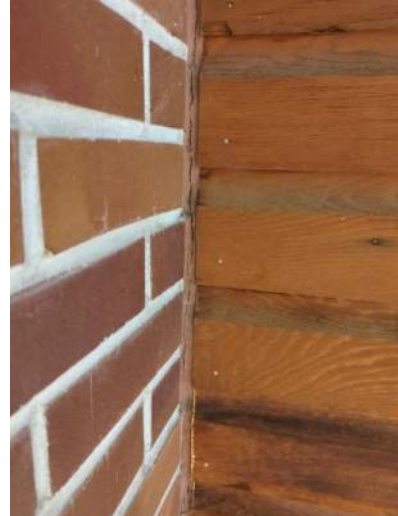
Record ID: 921
System: G2030 - PEDESTRIAN PLAZAS AND WALKWAYS
Item No.: G2030.20.002
Floor/Room: Exterior / Exterior
Priority: **Impending (2-3 Years)**
Quantity/Unit of Measure: 16/LF
Total Deficiency Cost: \$220
Deficiency Description: *Sealant failure on wall intersection was observed.*

Comments: *Located above south low roof.*

Description of Work: *Remove/replace sealant at joint.*

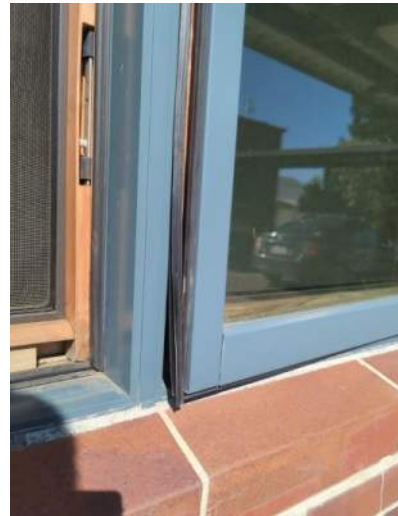
Record ID: 923
System: B2020 - EXTERIOR WINDOWS
Item No.: B2020.20.010
Floor/Room: Exterior / Exterior
Priority: **Necessary - Long Term (3-4 Years)**
Quantity/Unit of Measure: 16/LF
Total Deficiency Cost: \$480
Deficiency Description: *Metal clad window gasket are failing.*

Comments: *Windows located on south and east wall.*

Description of Work: *Replace window gaskets.*

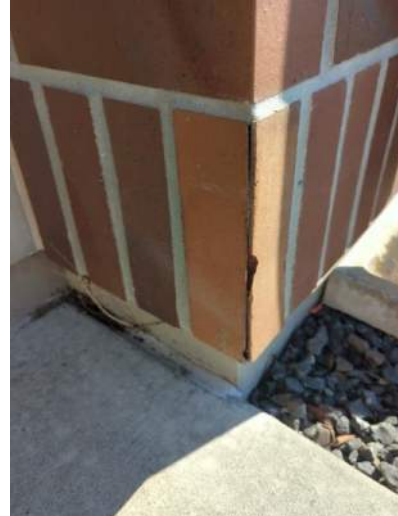
Item No.: B2010.10.004
Floor/Room: Exterior / Exterior
Priority: Necessary - Long Term (3-4 Years)
Quantity/Unit of Measure: 20/LF
Total Deficiency Cost: \$1,100
Deficiency Description: *Soldier brick outside corner is damaged.*

Comments: *Approximately 4 locations affected.*

Description of Work: *Repair brick masonry.*

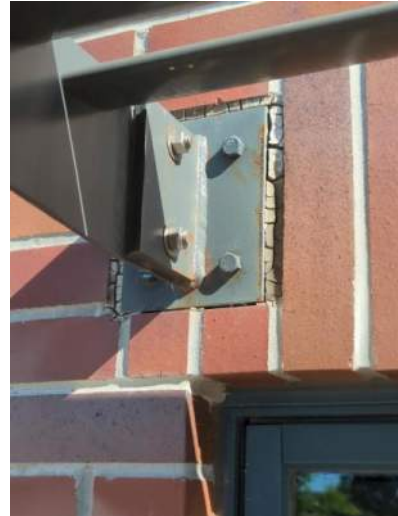
Item No.: B2050.90.009
Floor/Room: Exterior / Exterior
Priority: Necessary - Long Term (3-4 Years)
Quantity/Unit of Measure: 40/LF
Total Deficiency Cost: \$3,670
Deficiency Description: *Sealant around sunshades are failing.*

Comments: *Sealant around sunshade anchor plates to brick has failed.*

Description of Work: *Replace sealant.*

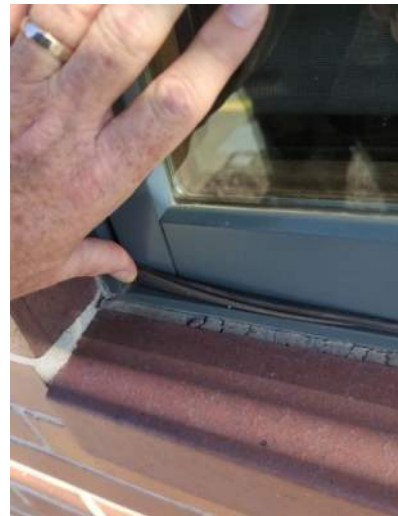
Item No.: B2050.90.011
Floor/Room: Exterior / Exterior
Priority: Crucial (1-2 Years)
Quantity/Unit of Measure: 1/EA
Total Deficiency Cost: \$860
Deficiency Description: *South window gaskets failing.*

Description of Work: *Remove and replace failed window gaskets.*

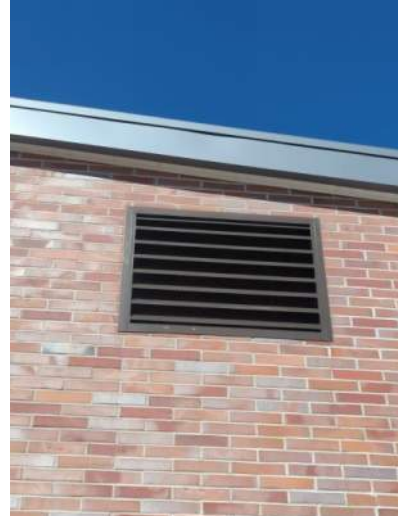
Record ID: 927
System: B2070 - EXTERIOR LOUVERS AND VENTS
Item No.: B2070.10.003
Floor/Room: Exterior / Exterior
Priority: Potential - Long Term (4-5 Years)
Quantity/Unit of Measure: 10/SF
Total Deficiency Cost: \$200
Deficiency Description: *Pre finished air intake louver finish failing.*

Description of Work: *Clean and repaint louvers as required.*

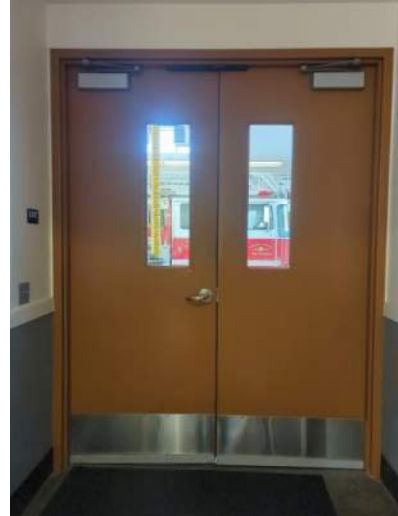
Item No.: B2050.90.003
Floor/Room: 1st Floor / Hallway
Priority: Potential - Long Term (4-5 Years)
Quantity/Unit of Measure: 2/EA
Total Deficiency Cost: \$1,140
Deficiency Description: *Metal door is showing signs of wear.*

Description of Work: *Refinish metal door.*

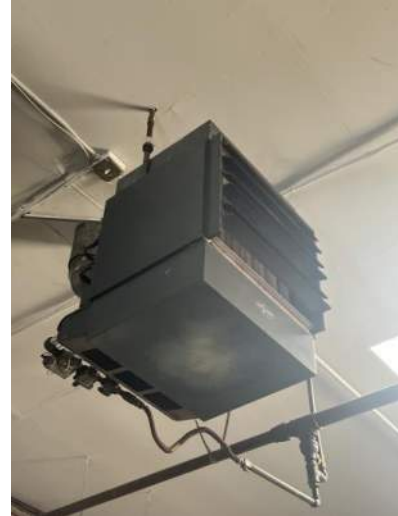
Item No.: D3020.70.003
Floor/Room: 1st Floor / Apparatus
Priority: **Impending (2-3 Years)**
Quantity/Unit of Measure: 1/EA
Total Deficiency Cost: \$13,140
Deficiency Description: *Gas fired unit heater is approaching the end of its expected useful life.*

Description of Work: *Provide equipment replacement and installation.*

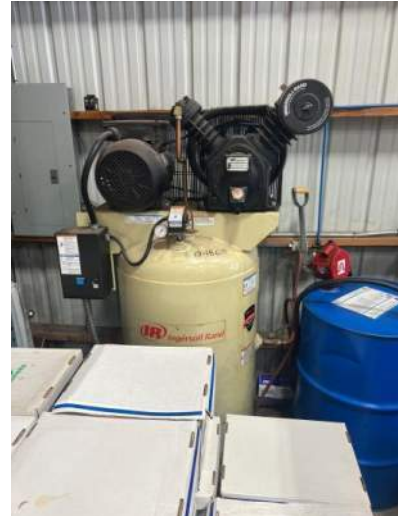
Item No.: D2060.10.001
Floor/Room: 1st Floor / Storage Building
Priority: **Planned - Long Term (6-10 Years)**
Quantity/Unit of Measure: 1/EA
Total Deficiency Cost: \$19,930
Deficiency Description: *Air compressor is approaching the end of its expected useful life.*

Comments: *Storage Building*

Description of Work: *Provide equipment replacement and installation.*

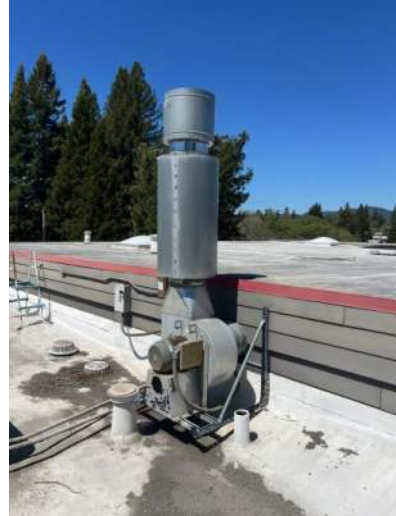
Comments: 3 Bay

Description of Work: *Provide equipment replacement and installation.*

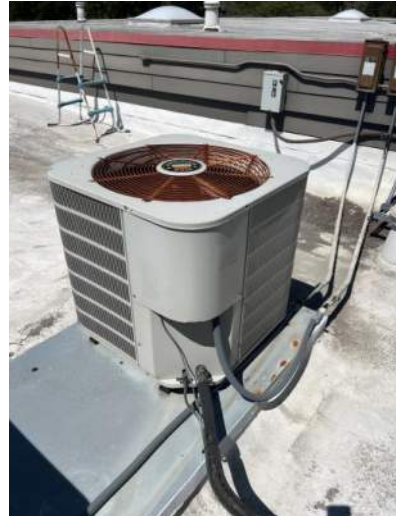
Item No.: D3030.70.006
Floor/Room: Roof / -
Priority: **Crucial (1-2 Years)**
Quantity/Unit of Measure: 1/EA
Total Deficiency Cost: \$12,190
Deficiency Description: *Split system with furnace heating and (2-ton) outdoor condensing unit is approaching the end of its expected useful life.*

Description of Work: *Provide equipment replacement and installation.*

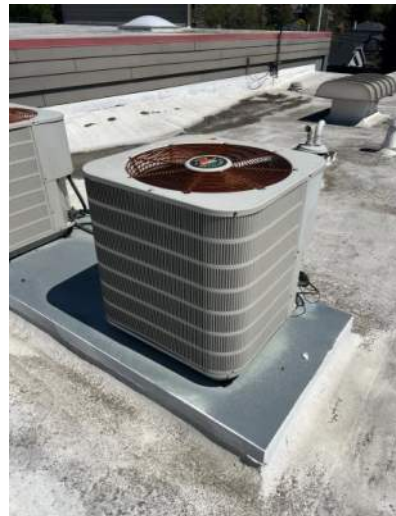
Item No.: D3030.70.006
Floor/Room: Roof / -
Priority: **Crucial (1-2 Years)**
Quantity/Unit of Measure: 1/EA
Total Deficiency Cost: \$12,190
Deficiency Description: *Split system with furnace heating and (2-ton) outdoor condensing unit is approaching the end of its expected useful life.*

Description of Work: *Provide equipment replacement and installation.*
