SONOMA COUNTY FIRE DISTRICT MASTER PLAN

FINAL REPORT | DEC 23, 2024

PREPARED BY KITCHELL AND SHAH KAWASAKI ARCHITECTS

Sonoma County Fire District
Facility Condition Assessment
MAY 31, 2024

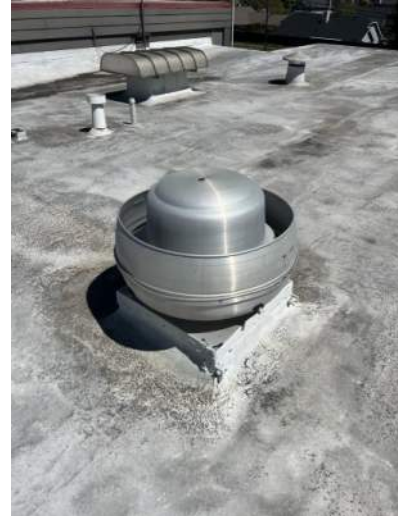
Item No.: D3060.30.005
Floor/Room: Roof / -
Priority: **Planned - Long Term (6-10 Years)**
Quantity/Unit of Measure: 1/EA
Total Deficiency Cost: \$8,780
Deficiency Description: *Roof exhaust fan is approaching the end of its expected useful life.*

Description of Work: *Provide equipment replacement and installation.*

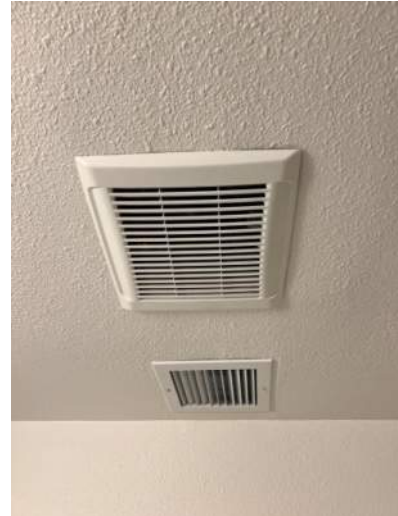
Item No.: D3060.30.002
Floor/Room: 1st Floor / Restroom 2
Priority: **Potential - Long Term (4-5 Years)**
Quantity/Unit of Measure: 1/EA
Total Deficiency Cost: \$2,680
Deficiency Description: *Ceiling exhaust fan is approaching the end of its expected useful life.*

Description of Work: *Provide equipment replacement and installation.*

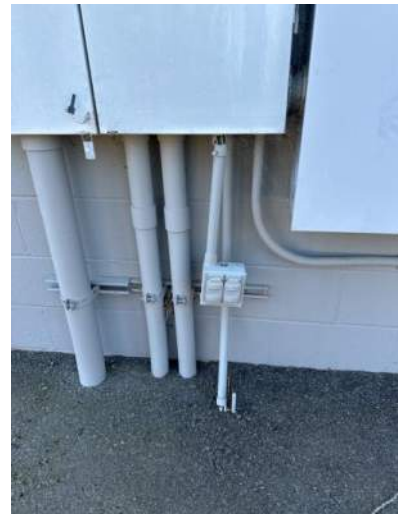
Item No.: D5030.50.040
Floor/Room: Site / -
Priority: Immediate (0-1 Years)
Quantity/Unit of Measure: 1/EA
Total Deficiency Cost: \$370
Deficiency Description: *Wiring device (outlet box, junction box, receptacle, etc.) needs to be secured to structure.*

Description of Work: *Secure the existing wiring device to the structure.*

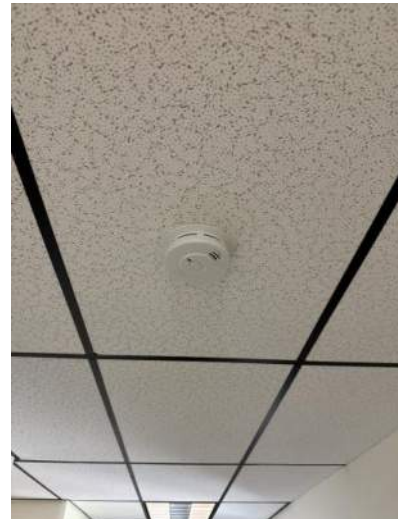
Installation of a new hardwired fire alarm system with full notification provided throughout the station is recommended. This would also allow for the fire alarm system to be remotely monitored.

Description of Work: *Provide a complete, site-wide, fully addressable fire alarm system.*

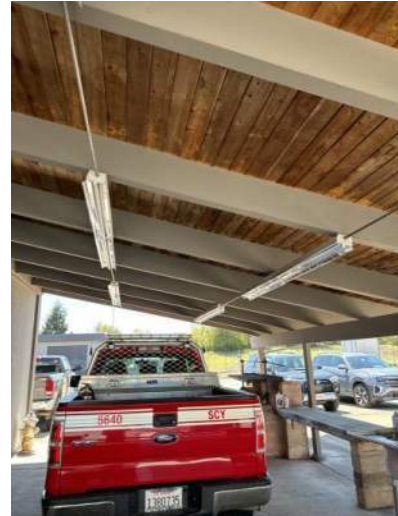
Item No.: D5040.50.003
Floor/Room: Site / -
Priority: Immediate (0-1 Years)
Quantity/Unit of Measure: 8/EA
Total Deficiency Cost: \$4,890
Deficiency Description: 1'W x 4'L two 40 watt surface mounted interior light fixture is damaged and should be replaced.

Description of Work: Replace the existing interior light fixture with a new interior light fixture.

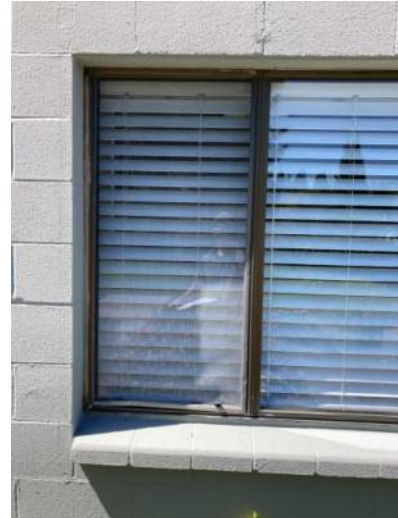
Item No.: B2020.10.012
Floor/Room: 1st Floor / Exterior
Priority: Impending (2-3 Years)
Quantity/Unit of Measure: 100/SF
Total Deficiency Cost: \$35,390
Deficiency Description: *The existing screens are deteriorated.*

Description of Work: *Replace exterior window screens.*

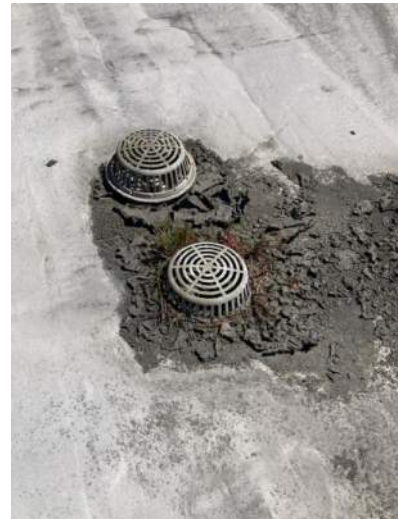
Record ID: 896
System: D2030 - BUILDING SUPPORT PLUMBING SYSTEMS
Item No.: D2030.30.001
Floor/Room: Roof / Upper Roof
Priority: Immediate (0-1 Years)
Quantity/Unit of Measure: 2/EA
Total Deficiency Cost: \$6,480
Deficiency Description: *Roof drains are damaged and clogged.*

Description of Work: *Repair or replace roof drains and provide cleaning.*

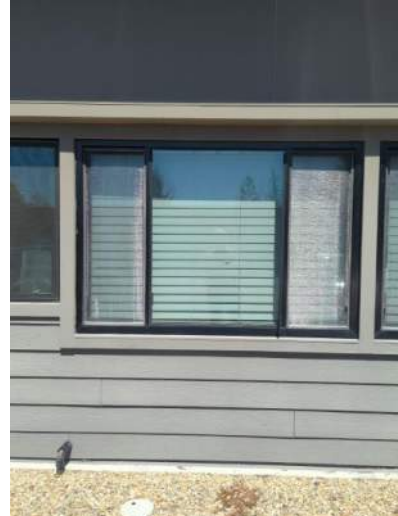
Record ID: 932
System: B2010 - EXTERIOR WALLS

Item No.: B2010.10.006
Floor/Room: 1st Floor / Exterior
Priority: **Crucial (1-2 Years)**
Quantity/Unit of Measure: 20/LF
Total Deficiency Cost: \$680
Deficiency Description: *Trim is showing signs of wood rot.*

Description of Work: *Replace trim and finish to match.*

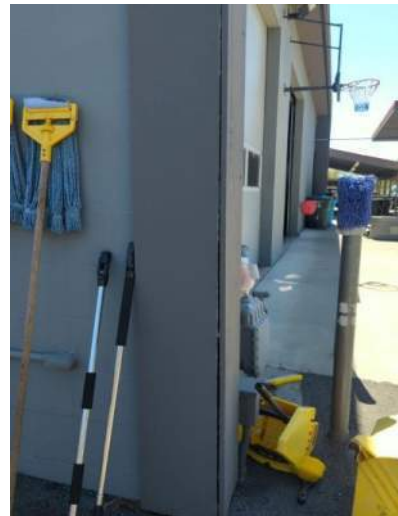
Record ID: 934
System: B2010 - EXTERIOR WALLS

Item No.: B2010.10.006
Floor/Room: 1st Floor / Apparatus Bay Exterior
Priority: **Crucial (1-2 Years)**
Quantity/Unit of Measure: 10/LF
Total Deficiency Cost: \$330
Deficiency Description: *Trim is worn and should be replaced.*

Comments: *At northwest corner.*

Description of Work: *Replace trim and finish to match.*

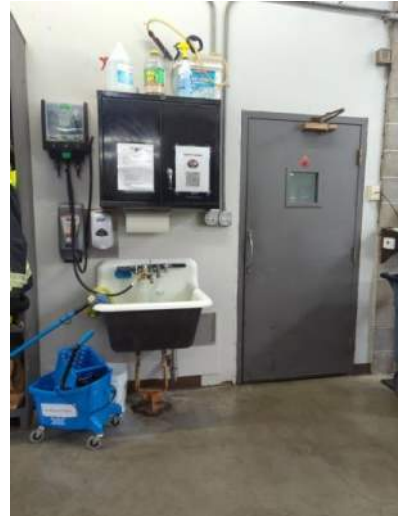
Record ID: 936
System: C2010 - WALL FINISHES

Item No.: C2010.70.001
Floor/Room: 1st Floor / Apparatus Bay
Priority: **Impending (2-3 Years)**
Quantity/Unit of Measure: 32/SF
Total Deficiency Cost: \$710
Deficiency Description: *Painted gypsum wallboard is showing signs of wear.*

Description of Work: *Patch and paint the gypsum wallboard.*

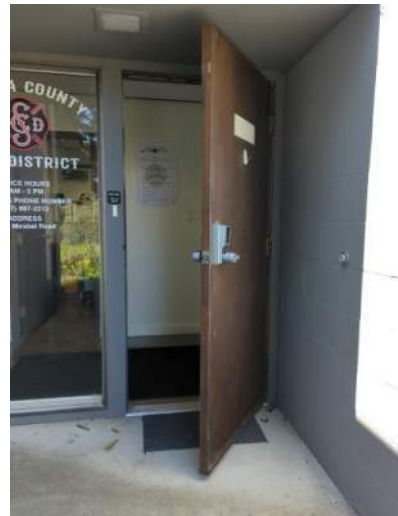
Record ID: 937
System: B2050 - EXTERIOR DOORS AND GRILLES

Item No.: B2050.10.006
Floor/Room: 1st Floor / Lobby
Priority: **Impending (2-3 Years)**
Quantity/Unit of Measure: 1/EA
Total Deficiency Cost: \$7,760
Deficiency Description: *Exterior wood entrance door, frame and hardware is approaching the end of its useful life.*

Description of Work: *Replace with steel door, frame, and hardware.*

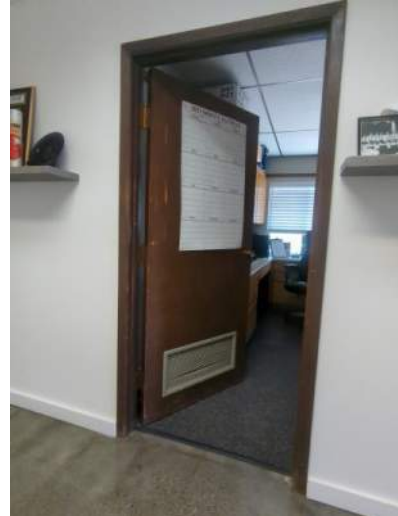
Record ID: 938
System: C1030 - INTERIOR DOORS

Item No.: C1030.10.008
Floor/Room: 1st Floor / -
Priority: **Necessary - Long Term (3-4 Years)**
Quantity/Unit of Measure: 5/EA
Total Deficiency Cost: \$5,540
Deficiency Description: *Interior wood doors in wood frames are visually in need of refurbishment.*

Description of Work: *Refurbish and restain the wood door.*

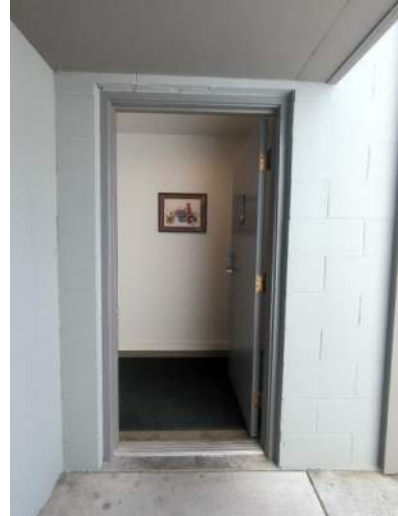
Deficiency Description: *Exterior wood entrance door, frame and hardware is approaching the end of its useful life.*

Comments: *Steel door in wood frame. Interior grade door, typ.*

Description of Work: *Replace with steel door, frame, and hardware.*

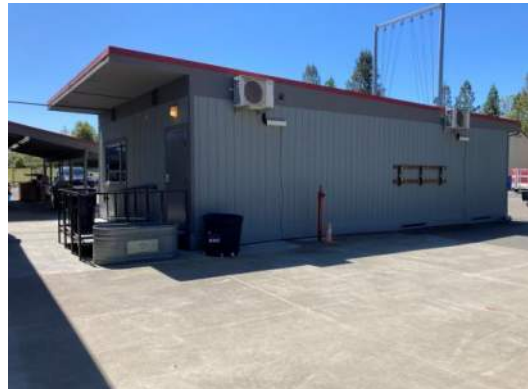
Record ID: 978
System: F1020 - SPECIAL STRUCTURES

Item No.: F1020.40.001
Floor/Room: Site / -
Priority: **Immediate (0-1 Years)**

Quantity/Unit of Measure: 1/LS
Total Deficiency Cost: \$882,300
Deficiency Description: *Modular building is approaching the end of its useful life.*

Description of Work: *Replace modular building in kind.*

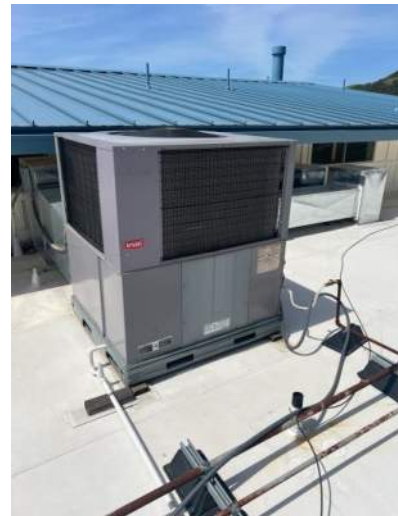
Record ID: 609
System: D3030 - COOLING SYSTEMS

Item No.: D3030.10.018
Floor/Room: Roof / -
Priority: **Planned - Long Term (6-10 Years)**
Quantity/Unit of Measure: 1/EA
Total Deficiency Cost: \$59,850
Deficiency Description: *Rooftop mounted packaged DX AC unit (5 tons) is approaching the end of its expected useful life.*

Description of Work: *Provide equipment replacement and installation.*

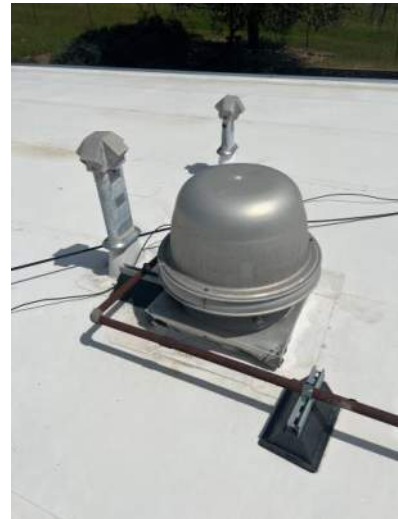
Record ID: 610
System: D3060 - VENTILATION

Item No.: D3060.30.005
Floor/Room: Roof / -
Priority: **Crucial (1-2 Years)**
Quantity/Unit of Measure: 1/EA
Total Deficiency Cost: \$7,460
Deficiency Description: *Roof exhaust fan is approaching the end of its expected useful life.*

Description of Work: *Provide equipment replacement and installation.*

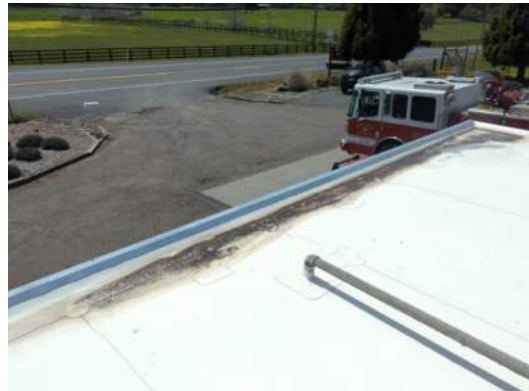
Record ID: 629
System: D2030 - BUILDING SUPPORT PLUMBING SYSTEMS

Item No.: D2030.30.001
Floor/Room: Roof / -
Priority: **Crucial (1-2 Years)**
Quantity/Unit of Measure: 2/EA
Total Deficiency Cost: \$6,780
Deficiency Description: *Roof drains are damaged and clogged.*

Description of Work: *Repair or replace roof drains.*

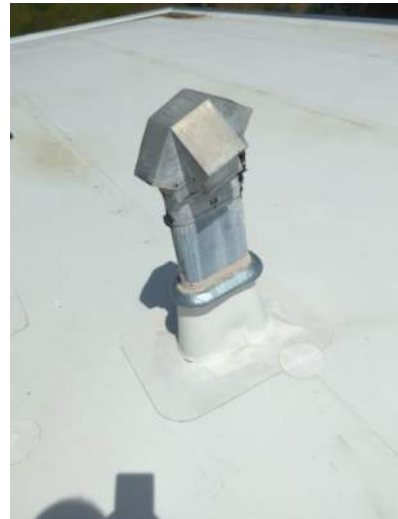
Record ID: 632
System: D3060 - VENTILATION

Item No.: D3060.70.001
Floor/Room: Roof / -
Priority: **Impending (2-3 Years)**
Quantity/Unit of Measure: 2/SF
Total Deficiency Cost: \$0
Deficiency Description: *Roof vent cap is loose.*

Description of Work: *Provide equipment maintenance.*

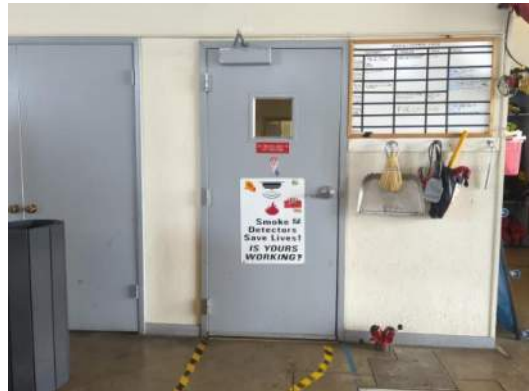
Record ID: 633
System: C1030 - INTERIOR DOORS

Item No.: C1030.10.003
Floor/Room: 1st Floor / Apparatus Bay
Priority: **Impending (2-3 Years)**
Quantity/Unit of Measure: 3/EA
Total Deficiency Cost: \$31,830
Deficiency Description: *Interior metal door is at or approaching the end of its useful life.*

Comments: *Door gets caught on frame.*

Description of Work: *Replace interior hollow metal door.*

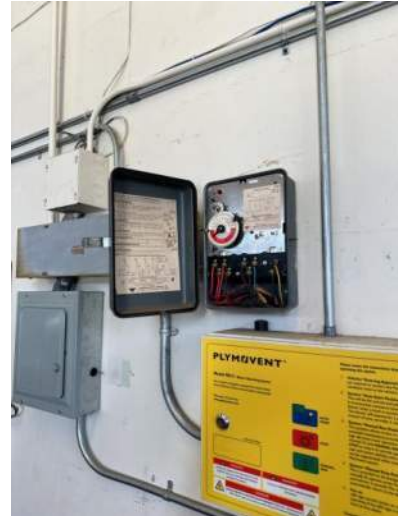
Description of Work: Replace the existing time clock with a new time clock.

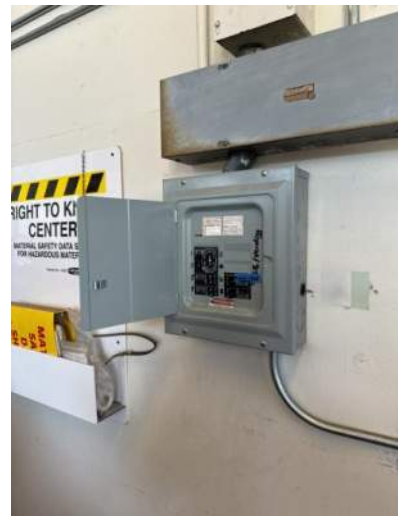
Record ID: 734
System: D5020 - ELECTRICAL SERVICE AND DISTRIBUTION

Item No.: D5020.30.4001
Floor/Room: 1st Floor / Apparatus Bay
Priority: Immediate (0-1 Years)
Quantity/Unit of Measure: 1/EA
Total Deficiency Cost: \$4,920
Deficiency Description: The 100A (18 ccts, 20A plug-in breakers, 1P) load center is approaching the end of its expected useful life.

Description of Work: Replace the existing load center with a new load center.

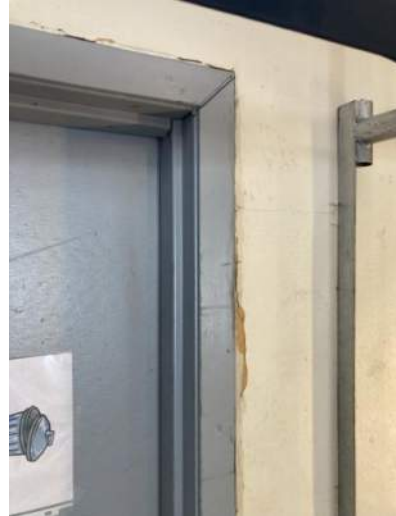
Item No.: B2050.10.005
Floor/Room: 1st Floor / Apparatus Bay
Priority: Potential - Long Term (4-5 Years)
Quantity/Unit of Measure: 1/EA
Total Deficiency Cost: \$5,770

Deficiency Description: *Exterior wood entrance door, frame and hardware is approaching the end of its useful life.*

Description of Work: *Replace wood door, frame, and hardware.*

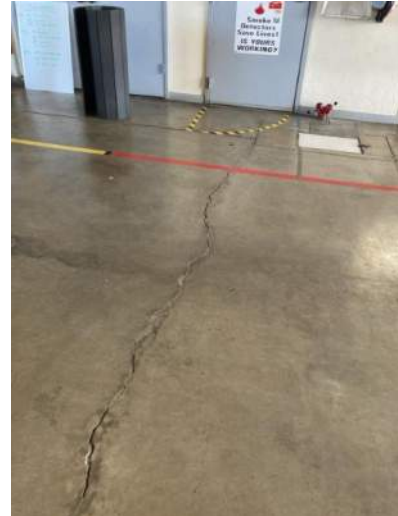
Record ID: 874
System: A4010 - STANDARD SLABS-ON-GRADE

Item No.: A4010.10.001
Floor/Room: 1st Floor / Apparatus Bay
Priority: Potential - Long Term (4-5 Years)
Quantity/Unit of Measure: 16/LF
Total Deficiency Cost: \$440
Deficiency Description: Excessive cracks were detected in the floor slab-on-grade.

Description of Work: Fill the slab-on-grade cracks with sealant.

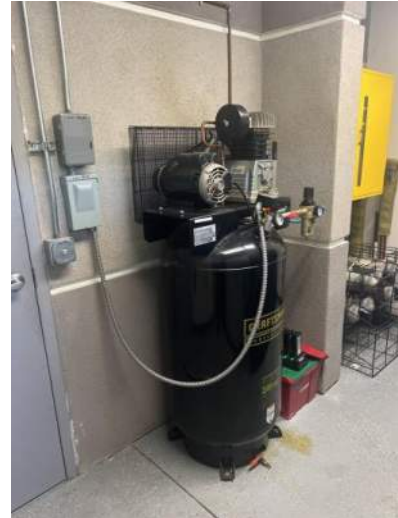
Record ID: 570
System: D2060 - PROCESS SUPPORT PLUMBING SYSTEMS

Item No.: D2060.10.001
Floor/Room: 1st Floor / Air Compressor
Priority: **Potential - Long Term (4-5 Years)**
Quantity/Unit of Measure: 1/EA
Total Deficiency Cost: \$19,180
Deficiency Description: *Air compressor is approaching the end of its expected useful life.*

Description of Work: *Provide equipment replacement and installation.*

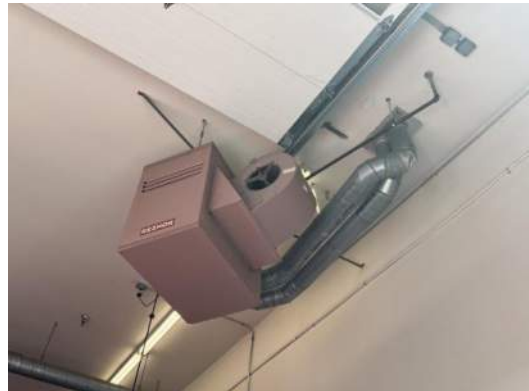
Record ID: 575
System: D3020 - HEATING SYSTEMS

Item No.: D3020.70.003
Floor/Room: 1st Floor / Apparatus
Priority: **Planned - Long Term (6-10 Years)**
Quantity/Unit of Measure: 1/EA
Total Deficiency Cost: \$14,800
Deficiency Description: *Gas fired unit heater is approaching the end of its expected useful life.*

Description of Work: *Provide equipment replacement and installation.*

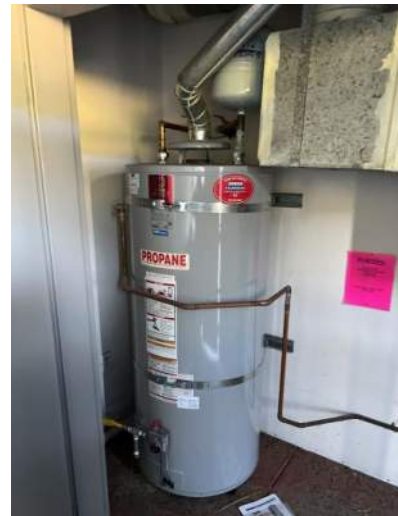
Record ID: 580
System: D2010 - DOMESTIC WATER DISTRIBUTION

Item No.: D2010.20.003
Floor/Room: 1st Floor / Mech Closet
Priority: **Planned - Long Term (6-10 Years)**
Quantity/Unit of Measure: 1/EA
Total Deficiency Cost: \$30,830
Deficiency Description: *Gas fired water heater is approaching the end of its expected useful life.*

Comments: *Propane water heater.*

Description of Work: *Provide equipment replacement and installation.*

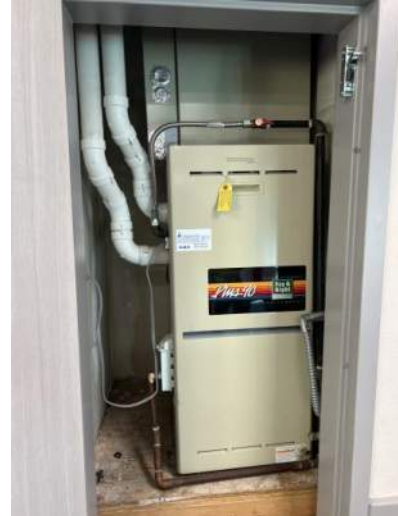
Item No.: D3020.10.007
Floor/Room: 1st Floor / Community Room (Thomas Burke)

Priority: **Impending (2-3 Years)**
Quantity/Unit of Measure: 1/EA
Total Deficiency Cost: \$18,760
Deficiency Description: *Gas-fired furnace is approaching the end of its expected useful life.*

Description of Work: *Provide equipment replacement and installation.*

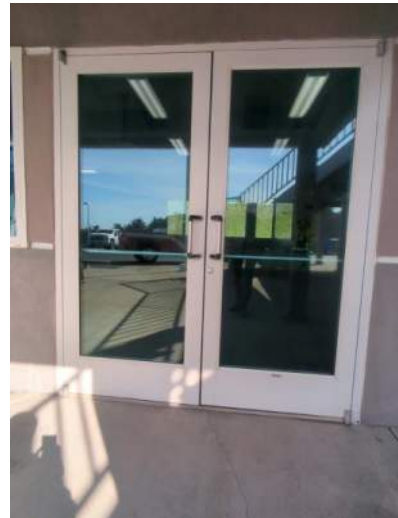
Item No.: B2050.90.009
Floor/Room: 1st Floor / Exterior Community Room

Priority: **Crucial (1-2 Years)**
Quantity/Unit of Measure: 75/LF
Total Deficiency Cost: \$6,360
Deficiency Description: *Polyurethane sealant is showing signs of damage.*

Comments: *Community Room entrance. Typical at all aluminum doors.*

Description of Work: *Replace sealant.*

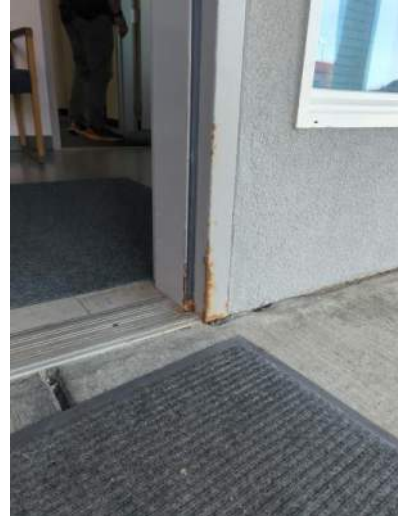
Comments: *At lobby, apparatus bay, rear apparatus bay, mech room, and community room exit door. The doors are wood.*

Description of Work: *Replace with steel door, frame, and hardware.*

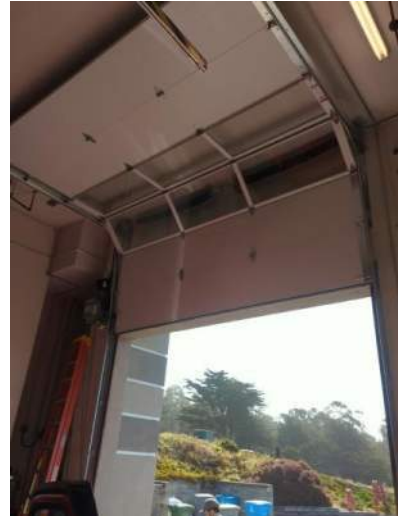
Record ID: 592
System: B2050 - EXTERIOR DOORS AND GRILLES

Item No.: B2050.30.002
Floor/Room: 1st Floor / Exterior
Priority: **Necessary - Long Term (3-4 Years)**
Quantity/Unit of Measure: 1/EA
Total Deficiency Cost: \$20,300
Deficiency Description: *Center Bay door is approaching the end of its expected useful life.*

Comments: *East door has been replaced more recently.*

Description of Work: *Provide equipment replacement and installation.*

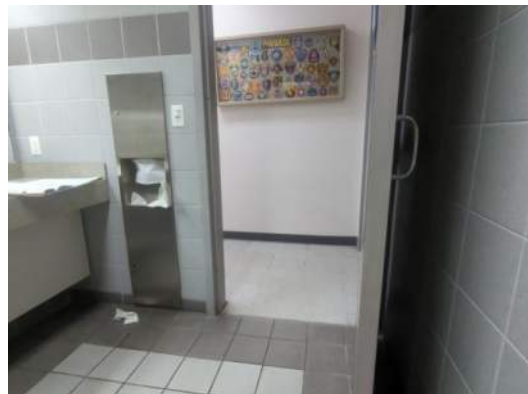
Record ID: 599
System: C1030 - INTERIOR DOORS

Item No.: C1030.10.009
Floor/Room: 1st Floor / Men's Toilet
Priority: **Potential - Long Term (4-5 Years)**
Quantity/Unit of Measure: 1/EA
Total Deficiency Cost: \$1,140
Deficiency Description: *Metal door and frame is corroded.*

Description of Work: *Refurbish/repair interior door and frame.*

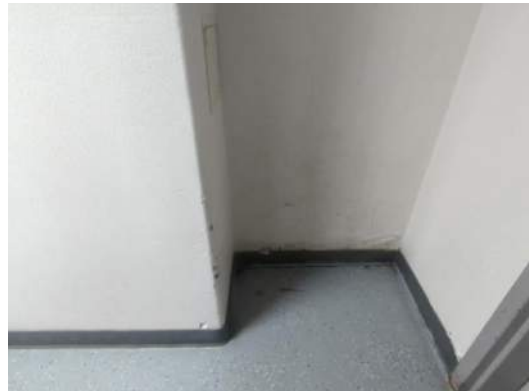
Record ID: 624
System: C2010 - WALL FINISHES

Item No.: C2010.70.001
Floor/Room: 1st Floor / Laundry
Priority: Necessary - Long Term (3-4 Years)
Quantity/Unit of Measure: 5/SF
Total Deficiency Cost: \$130
Deficiency Description: *Painted gypsum wallboard is showing signs of wear.*

Description of Work: *Patch and paint the gypsum wallboard.*

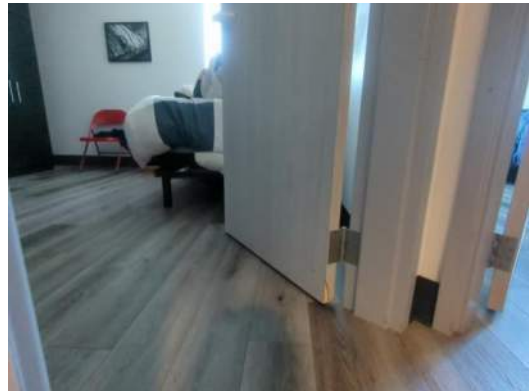
Record ID: 627
System: B2050 - EXTERIOR DOORS AND GRILLES

Item No.: B2050.10.007
Floor/Room: 2nd Floor / Dorm Room 2
Priority: Potential - Long Term (4-5 Years)
Quantity/Unit of Measure: 1/EA
Total Deficiency Cost: \$6,000
Deficiency Description: *Damaged plastic laminate on door edge.*

Description of Work: *Refurbish/repair wood door.*

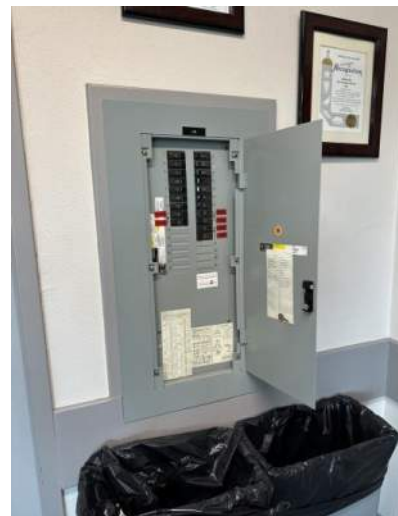
Record ID: 642
System: D5020 - ELECTRICAL SERVICE AND DISTRIBUTION

Item No.: D5020.30.1001
Floor/Room: 1st / Community
Priority: Necessary - Long Term (3-4 Years)
Quantity/Unit of Measure: 1/EA
Total Deficiency Cost: \$9,440
Deficiency Description: *The 100A (20 ckts, 120/240V, 3P) panelboard is approaching the end of its expected useful life.*

Description of Work: *Replace the existing panelboard with a new panelboard.*

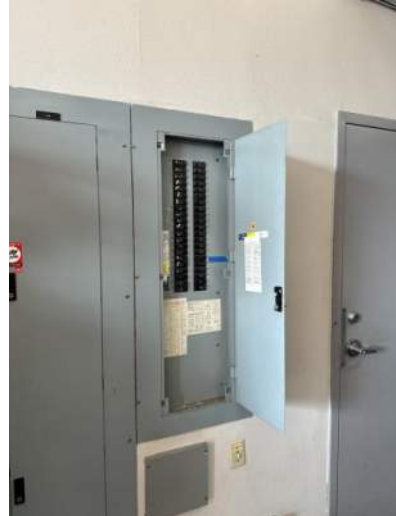
Record ID: 644
System: D5020 - ELECTRICAL SERVICE AND DISTRIBUTION
Item No.: D5020.30.1001
Floor/Room: 1st / Apparatus
Priority: Necessary - Long Term (3-4 Years)
Quantity/Unit of Measure: 1/EA
Total Deficiency Cost: \$9,440
Deficiency Description: The 100A (20 ckts, 120/240V, 3P) panelboard is approaching the end of its expected useful life.

Description of Work: Replace the existing panelboard with a new panelboard.

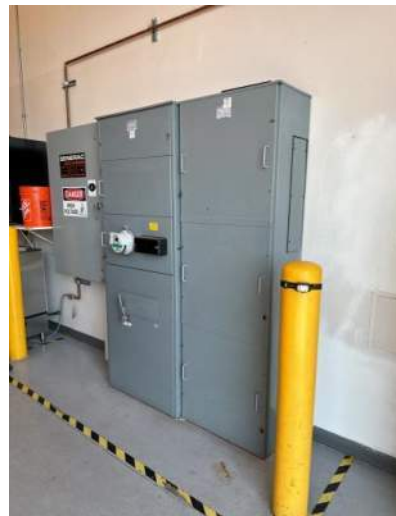
Record ID: 645
System: D5020 - ELECTRICAL SERVICE AND DISTRIBUTION
Item No.: D5020.10.302
Floor/Room: 1st / Apparatus
Priority: Necessary - Long Term (3-4 Years)
Quantity/Unit of Measure: 1/EA
Total Deficiency Cost: \$20,360
Deficiency Description: The 400A metered main switchboard (3P, 120/208) is approaching the end of its expected useful life.

Description of Work: Replace the existing metered main switchboard with a new metered main switchboard.

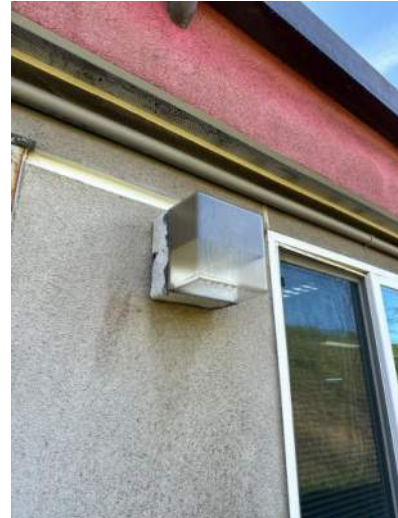
Record ID: 713
System: D5040 - LIGHTING

Item No.: D5040.50.304
Floor/Room: Site / -
Priority: Immediate (0-1 Years)
Quantity/Unit of Measure: 13/EA
Total Deficiency Cost: \$19,860
Deficiency Description: *The wall pack is approaching the end of its useful life and should be replaced.*

Description of Work: *Replace the existing lighting fixture with a new lighting fixture.*

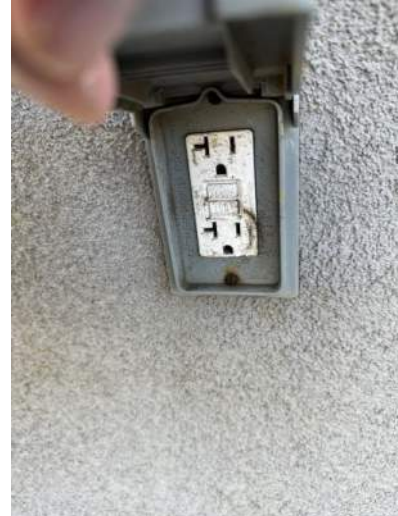
Record ID: 717
System: D5030 - GENERAL PURPOSE ELECTRICAL POWER
Item No.: D5030.50.011
Floor/Room: Site / -
Priority: Immediate (0-1 Years)
Quantity/Unit of Measure: 10/EA
Total Deficiency Cost: \$1,750
Deficiency Description: *Weatherproof receptacles are damaged and should be replaced.*

Description of Work: *Replace the existing receptacle with a weatherproof receptacle,*

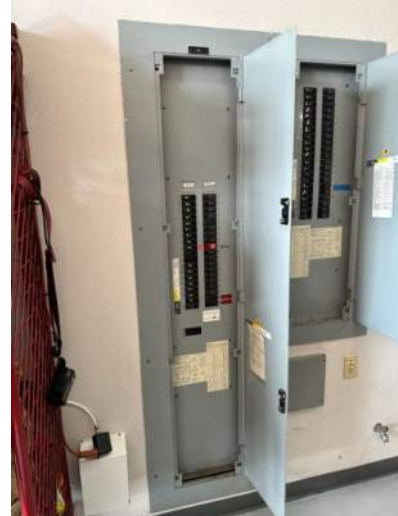
Record ID: 718
System: D5020 - ELECTRICAL SERVICE AND DISTRIBUTION
Item No.: D5020.30.1002
Floor/Room: 1st / Apparatus
Priority: Necessary - Long Term (3-4 Years)
Quantity/Unit of Measure: 1/EA
Total Deficiency Cost: \$21,000
Deficiency Description: *The 225A (42 ckts, 120/240V, 3P) panelboard is approaching the end of its expected useful life.*

Comments: *Missing screws.*

Description of Work: *Replace the existing panelboard with a new panelboard.*

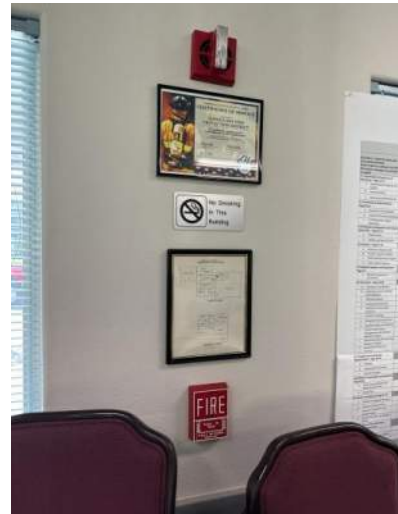
Record ID: 719
System: D7050 - DETECTION AND ALARM
Item No.: D7050.10.018
Floor/Room: All / Various
Priority: Immediate (0-1 Years)
Quantity/Unit of Measure: 30/EA
Total Deficiency Cost: \$39,660
Deficiency Description: *The fire alarm field devices are at the end of its expected useful life.*

Description of Work: *Replace the existing devices.*

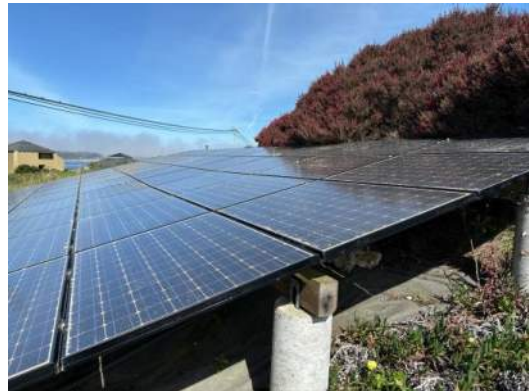
Record ID: 721
System: D5010 - FACILITY POWER GENERATION

Item No.: D5010.30.003
Floor/Room: Site / -
Priority: Necessary - Long Term (3-4 Years)
Quantity/Unit of Measure: 20,000/W
Total Deficiency Cost: \$814,480
Deficiency Description: *The ground mouted photovoltaic power system is in approaching the end of its useful life.*

Comments: *108 panels*

Description of Work: *Replace the existing photovoltaic power system and with a new one.*

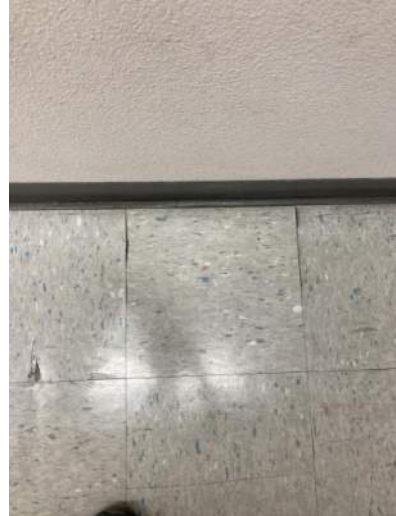
Item No.: C2030.50.001
Floor/Room: 1st Floor / Hallway
Priority: Potential - Long Term (4-5 Years)
Quantity/Unit of Measure: 200/SF
Total Deficiency Cost: \$5,770
Deficiency Description: Vinyl composition tile is approaching the end of its useful life.

Comments: Evident subgrade water intrusion in the slab on grade with staining of vinyl composition tile joints and some loose tiles.

Description of Work: Remove the existing vinyl composition tile and replace.

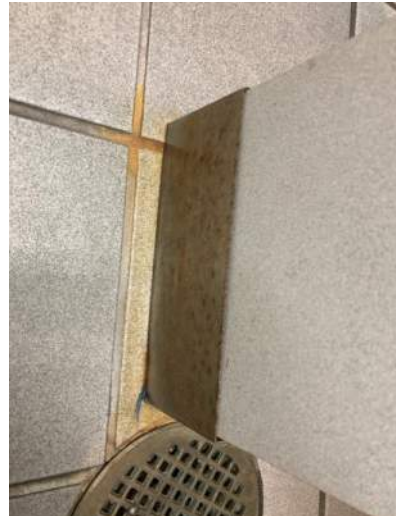
Record ID: 850
System: C1090 - INTERIOR SPECIALTIES

Item No.: C1090.25.001
Floor/Room: 1st Floor / Mens RR
Priority: Potential - Long Term (4-5 Years)
Quantity/Unit of Measure: 1/EA
Total Deficiency Cost: \$4,590
Deficiency Description: Corroding on the base of partition in the mens restroom.

Description of Work: Replace the toilet partitions.

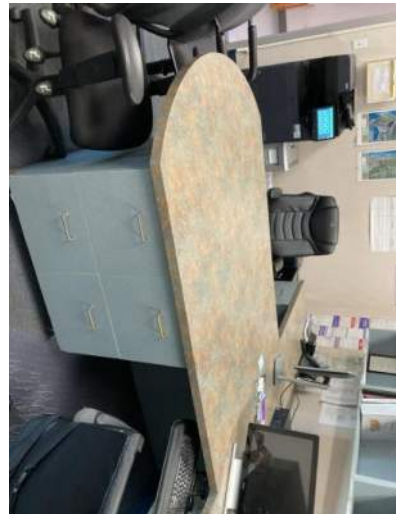
Record ID: 851
System: E2010 - FIXED FURNISHINGS

Item No.: E2010.30.001
Floor/Room: 1st Floor / Office
Priority: Potential - Long Term (4-5 Years)
Quantity/Unit of Measure: 10/LF
Total Deficiency Cost: \$1,540
Deficiency Description: Plastic laminate countertops are at or are approaching the end of their useful life.

Description of Work: Repair or replace plastic laminate countertops.

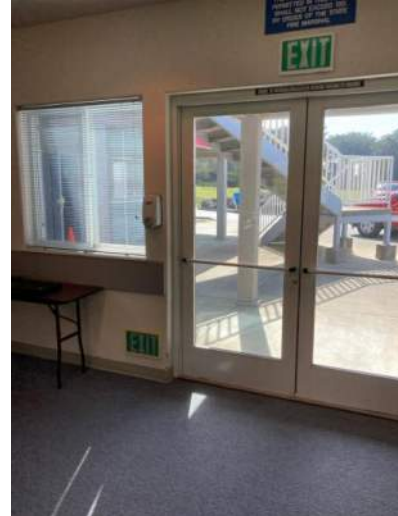
Record ID: 852
System: C2030 - FLOORING

Item No.: C2030.90.001
Floor/Room: 1st Floor / Conference
Priority: Potential - Long Term (4-5 Years)
Quantity/Unit of Measure: 40/LF
Total Deficiency Cost: \$740
Deficiency Description: 6" Vinyl wall base is approaching the end of its useful life.

Description of Work: Replace the vinyl wall base.

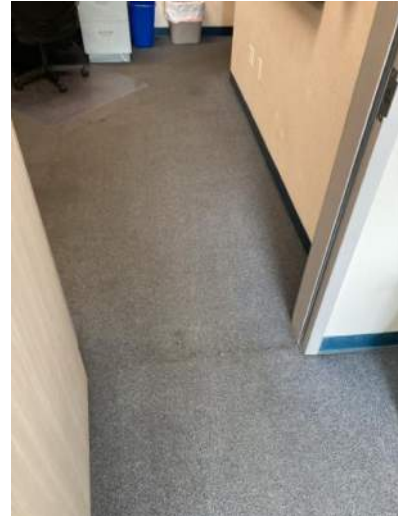
Record ID: 853
System: C2030 - FLOORING

Item No.: C2030.75.001
Floor/Room: 1st Floor / Chief's office
Priority: Potential - Long Term (4-5 Years)
Quantity/Unit of Measure: 8/SF
Total Deficiency Cost: \$230
Deficiency Description: Carpet tile is damaged.

Description of Work: Replace carpet tile.

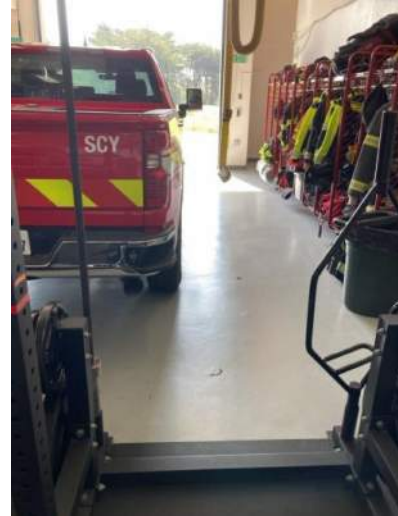
Item No.: C2030.10.002
Floor/Room: 1st Floor / App bay
Priority: Potential - Long Term (4-5 Years)
Quantity/Unit of Measure: 400/SF
Total Deficiency Cost: \$23,030
Deficiency Description: *Epoxy is approaching the end of its useful life.*

Description of Work: *Remove the existing epoxy and replace.*

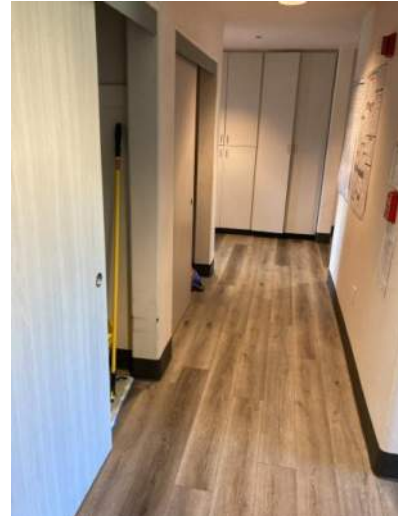
Record ID: 860
System: C2010 - WALL FINISHES

Item No.: C2010.70.001
Floor/Room: 2nd Floor / Living quarters hallway closet
Priority: Potential - Long Term (4-5 Years)
Quantity/Unit of Measure: 10/SF
Total Deficiency Cost: \$230
Deficiency Description: *Painted gypsum wallboard is showing signs of wear.*

Description of Work: *Patch and paint the gypsum wallboard.*

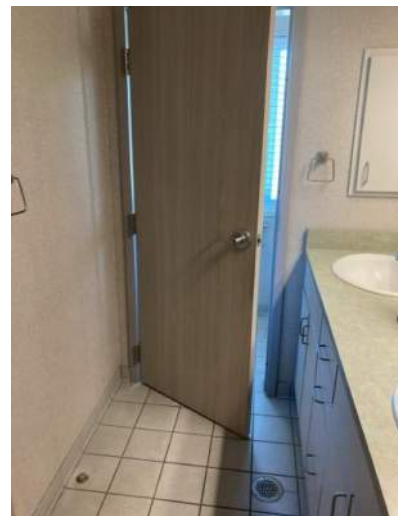
Record ID: 861
System: C1030 - INTERIOR DOORS

Item No.: C1030.10.008
Floor/Room: 2nd Floor / -
Priority: Potential - Long Term (4-5 Years)
Quantity/Unit of Measure: 3/EA
Total Deficiency Cost: \$3,450
Deficiency Description: *Interior wood door is in visual need of refurbishment.*

Description of Work: *Refurbish and restain the wood door.*

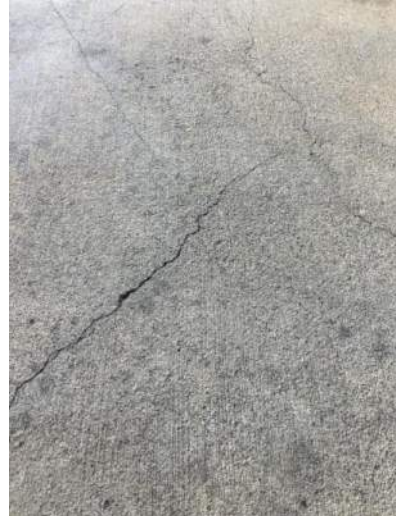
Record ID: 867
System: A4010 - STANDARD SLABS-ON-GRADE

Item No.: A4010.10.001
Floor/Room: 2nd Floor / Balcony
Priority: Potential - Long Term (4-5 Years)
Quantity/Unit of Measure: 10/LF
Total Deficiency Cost: \$270
Deficiency Description: Excessive cracks were detected in concrete patio deck.

Description of Work: Fill the patio deck cracks with sealant.

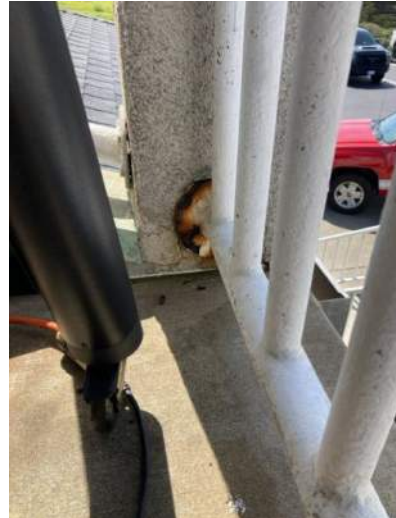
Record ID: 868
System: B2080 - EXTERIOR WALL APPURTENANCES

Item No.: B2080.50.004
Floor/Room: 2nd Floor / Balcony
Priority: Crucial (1-2 Years)
Quantity/Unit of Measure: 15/LF
Total Deficiency Cost: \$6,360
Deficiency Description: Guardrail is showing signs of corrosion.

Description of Work: Repair/replace handrails/guardrails.
